‘Stitching up’ the past – The strengthening of three heritage marine structures in Jersey with needling technology

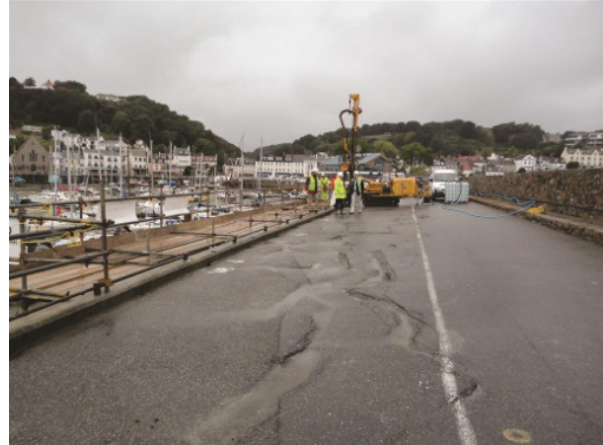
In 2001 the North Pier was assessed as being in a state of instability due to movement of its internal wall and apparent settlement of the interior of the pier. The deck level of the North Pier is surfaced in asphalt which waterproofs the deck but also masks (to a certain extent) masonry movements. Large cracks however had developed and could be seen in the asphalt indicating a threat of impending wedge failure of a section of the inner wall.

North Pier - cracks at deck level

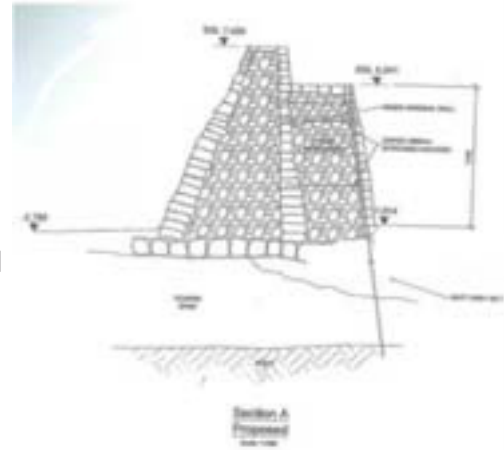
Figure 13 - St. Aubin's Fort inner wall ties and mini piles

St Aubin’s Fort Breakwater has in turn suffered a re-occurrence of masonry movements and loss of pointing at its inner, lower deck wall. In 2008 a bulge was also identified in part of this inner wall which prompted concerns about this part of the breakwater’s structural integrity.

The quality of the grout that was pumped into the end of the structure in 1972 was found (in 2009) to now be of deteriorating variable quality and consistency. However, it was not thought pragmatic or cost effective to dismantle this end of the lower deck structure and rebuild it in its original form, whilst the 'stitching' anchor solution provided clear benefits allowing the structure to be anchored and stitched together without changing its character and with minimal impact.

In order to optimise the number of anchors, an iterative process was used, finding the optimum spacing to satisfy the onerous load criteria imposed by the sea conditions in such an exposed location. Horizontal ties were inserted through the inner wall of the main breakwater so that the inside face wall of the lower deck was not only tied to the inner bulk of the original wall but also had additional cantilevered 'beam' support.
