Worcester Viaduct

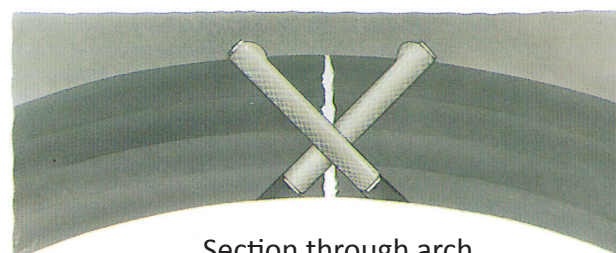
Section through arch

Worcester Viaduct comprises sixty-five brickwork arches rising from approximately two storey height near the railway station to over three storey height as it approaches the river. Lack of proper draining within the arch had led to the spandrel walls being forced away from the intrados arch with longitudinal cracks close to the longitudinal edges of the bridge. Water penetration had contributed to cracking at the springings of some spans and delamination of external parts of some columns. These problems had been exacerbated by weathering, particularly freezing and thawing. Previous efforts to restore the structural integrity were evident, but had proved ineffective.

Transverse 30 x 30 x 3 SHS stainless steel WSA anchors were installed to restore the integrity of the spandrel wall/ intrados arch connection at approximately 750mm centre-to-centre and alternate lengths of 2.0m and 2.5m. Stitching anchors were angled across the longitudinal cracks to restore structural integrity and the cracks were then filled. Transverse and diagonal stitching anchors, type RWT, 15 x 15 x 1.5 SHS stainless steel, were installed to restore the strength of the delaminated columns and the cracks filled. Drainage holes were drilled through the intrados and plastic pipes were installed to help relieve the existing water pressure. To date five spans have been renovated using the Cintec system and further spans will be renovated as part of an ongoing maintenance programme.
