# Cintec Strengthening and Repair for the Rail Industry.

**A Selection of Cintec Case Histories  
Spanning Three Decades.**

# INDEX

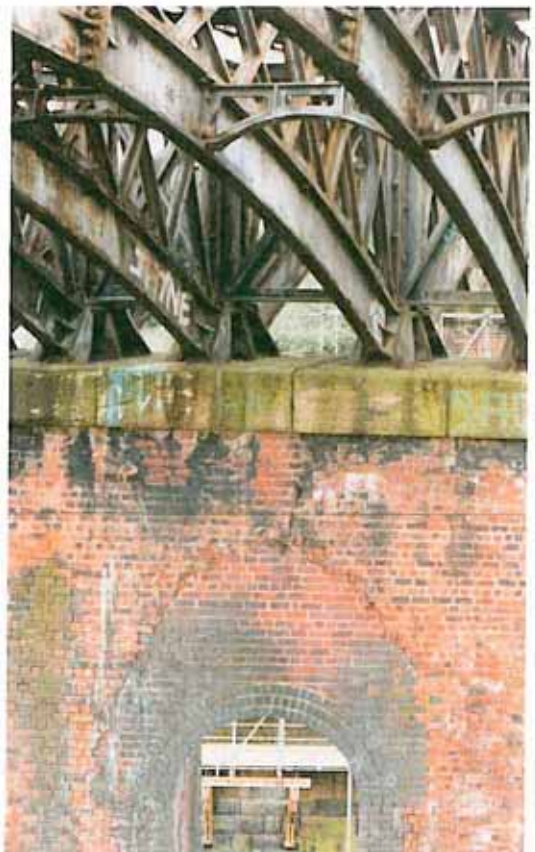
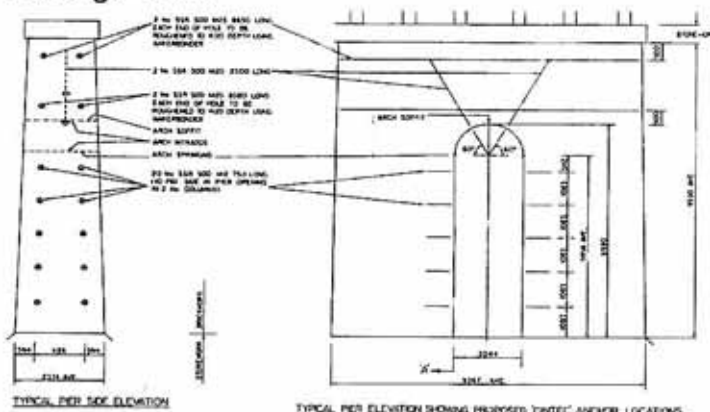
British Rail had previously attempted to strengthen the four tapering brickwork pillars by adding new masonry to the original single archway piercings located in each pier. This new work had however begun to detach from the original structure and extensive cracking was visible between the new and the old (see right).

Cintec supplied 108 stud and rebar stitching anchors ranging from 1 to 10 metres in length. These were installed through the cracks to re-connect the inner reinforcement brickwork to the original structure as indicated in the design proposal below.

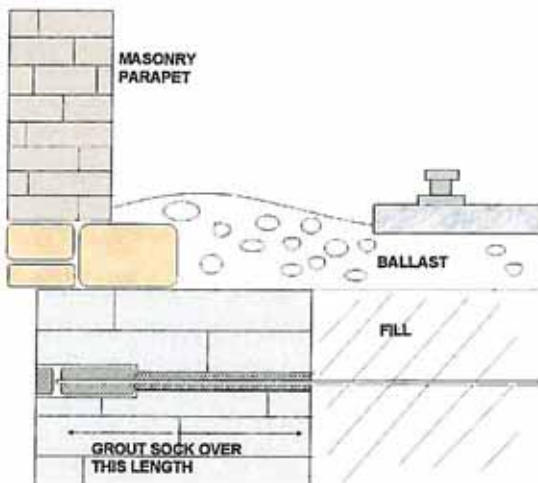
Cross sectional view of 5 metre three piece Cintec anchor.

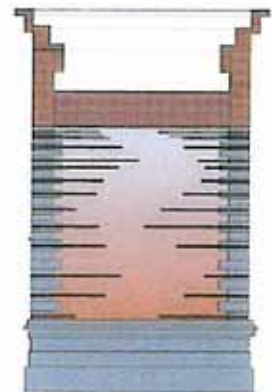
Vertical cross section of arch stitching.

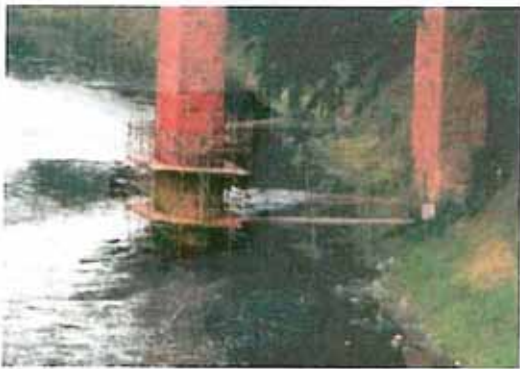
View of drilling platform

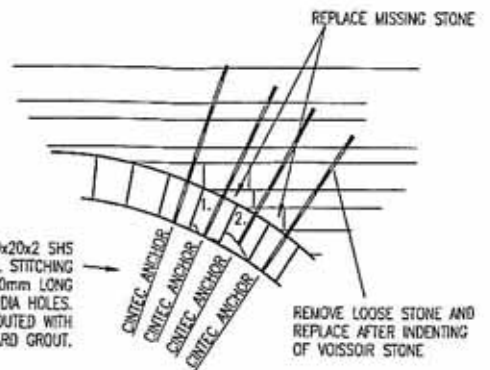
PART ELEVATION OF VOISSORS/SPANDREL FACE

The second phase of work involved interlocking the outer masonry walls of each pier. The original design drawings and the photograph (below and right) reveal the extent of the cracking and the subsequent Cintec solution. In total 112 anchors were installed.

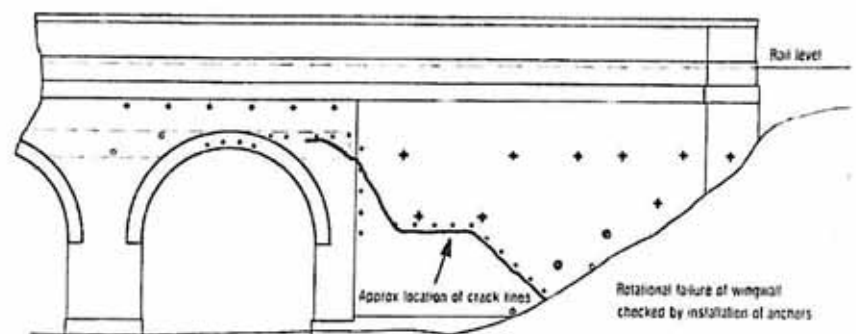
- Spandrel anchors 16mm dia HYS
- Wingwall anchors 25mm dia HYS
- Trial anchors
- Stitching anchors
- Drainage holes

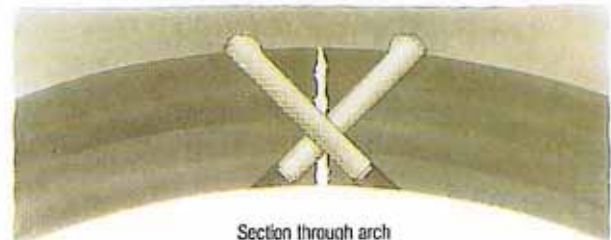
Section through arch

Transverse 30 x 30 x 3 SHS stainless steel WSA anchors were installed to restore the integrity of the spandrel wall/intrados arch connection at approximately 750mm centre-to-centre and alternate lengths of 2.0m and 2.5m. Stitching anchors were angled across the longitudinal cracks to restore structural integrity and the cracks were then filled. Transverse and diagonal stitching anchors, type RWT, 15 x 15 x 1.5 SHS stainless steel, were installed to restore the strength of the delaminated columns and the cracks filled. Drainage holes were drilled through the

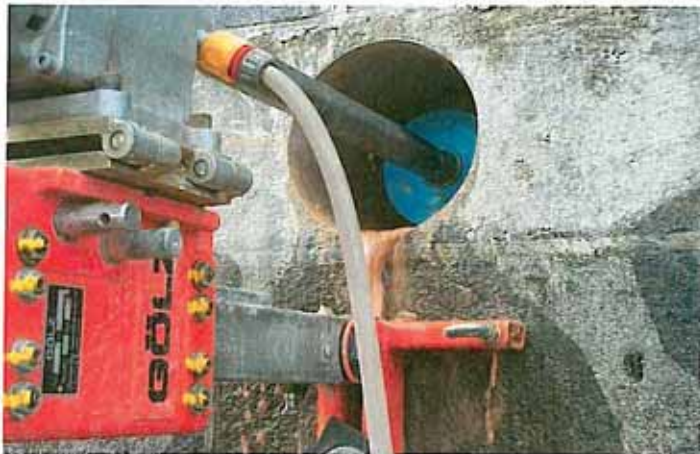
Core Drilling

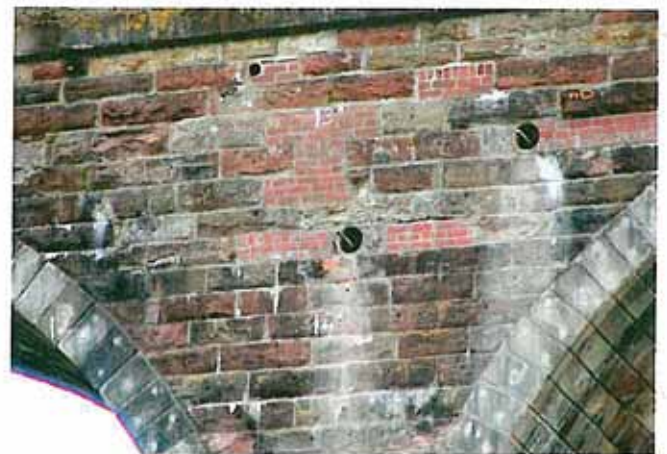
Anchor Placement

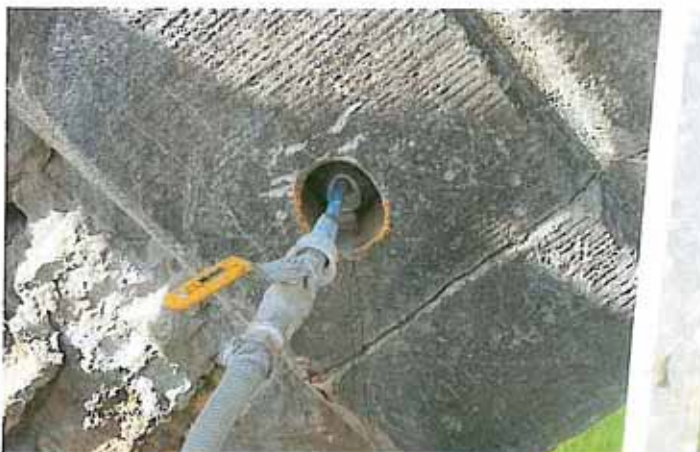
Anchor grout injection

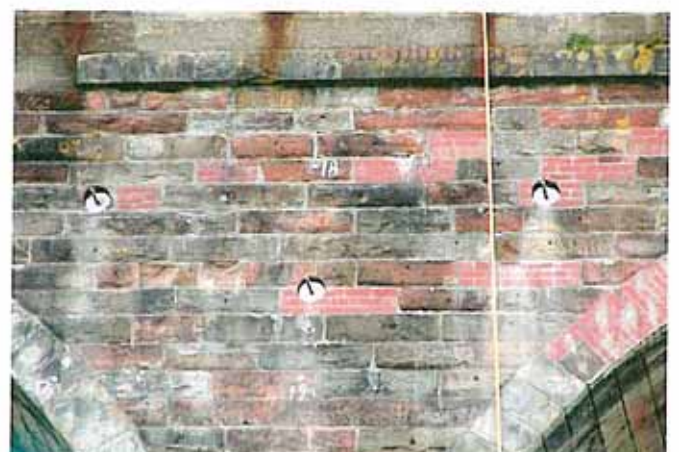
Inflated pipe anchors (Holes subsequently plugged and hidden).

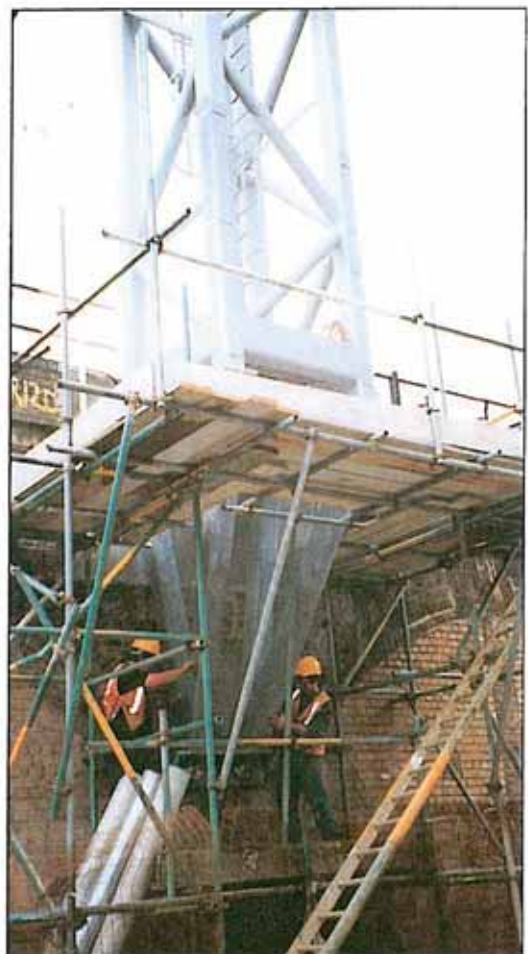
The torquing of the anchors

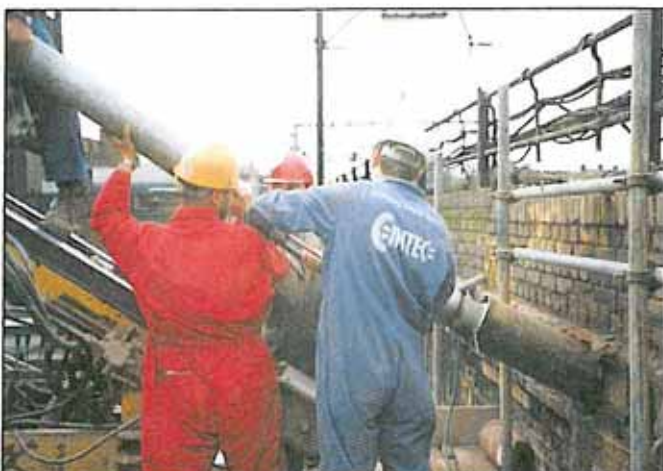
The assembling and installation of a compression anchor

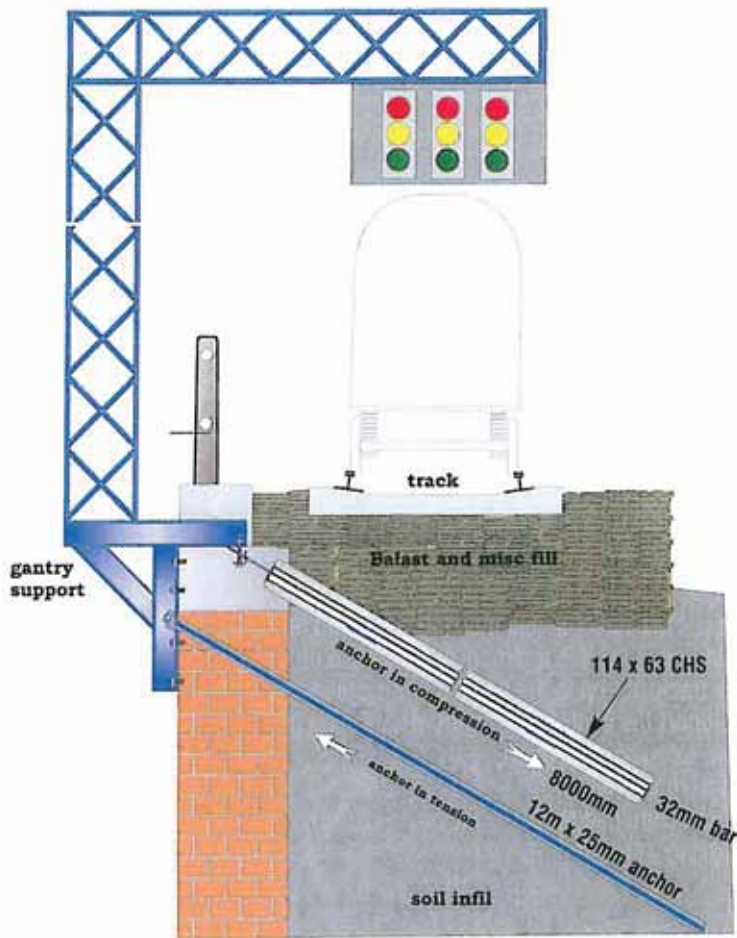
FOUNDATION DETAILS OF ANCHOR ARRANGEMENT TO SIGNAL CANTILEVER FOR BRITISH RAILWAYS AT FENCHURCH STREET STATION LONDON

The proposed solution involved three CINTEC Anchor types. The central one was a compression anchor of stainless steel comprising a 32mm shell rebar inside a 114 x 6.3 CHS installed in a 200mm hole, 8000mm deep, at an angle of 30 degrees to the horizontal. Below it was a tension anchor, comprising a solid stainless steel body, 12m x 25mm installed in a 50mm drilled hole, and attached to the gantry support to prevent any rotation. Two smaller shear anchors 20mm x 800mm were similarly installed to complete the support. Load tests were carried out, with the placing of a 20m steel beam in position.

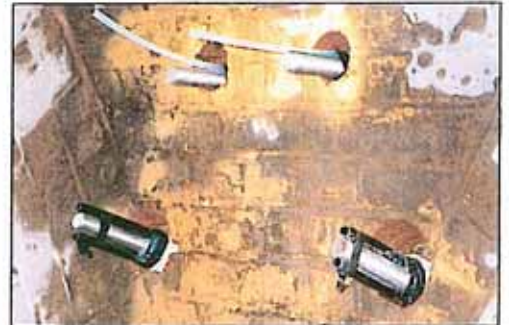
Shear anchors shown at the top and tension anchors at the bottom

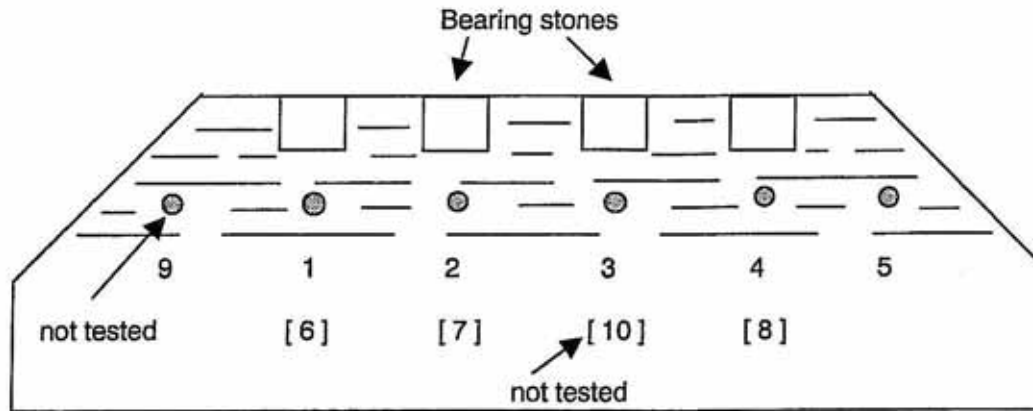
**ELEVATION OF NORTH & SOUTH ABUTMENT SHOWING GROUND ANCHORS  
SOUTHERN ANCHORS 1 – 5  
NORTHERN ANCHORS 6 - 8**

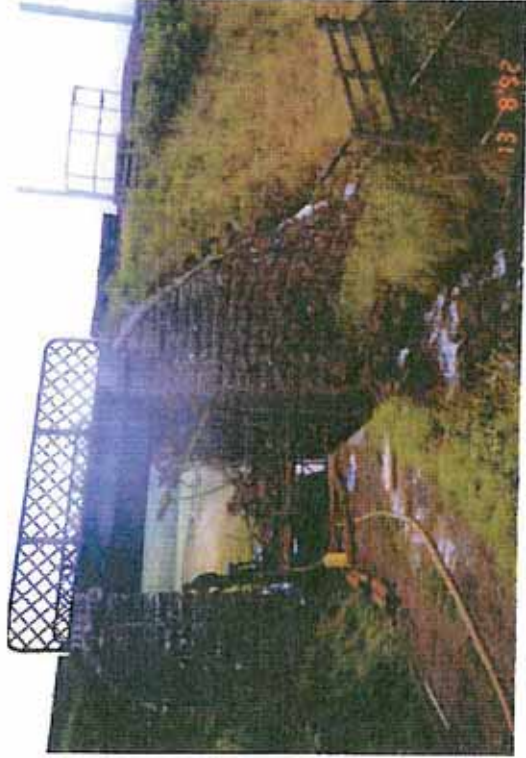
Diamond Core Drilling Rig

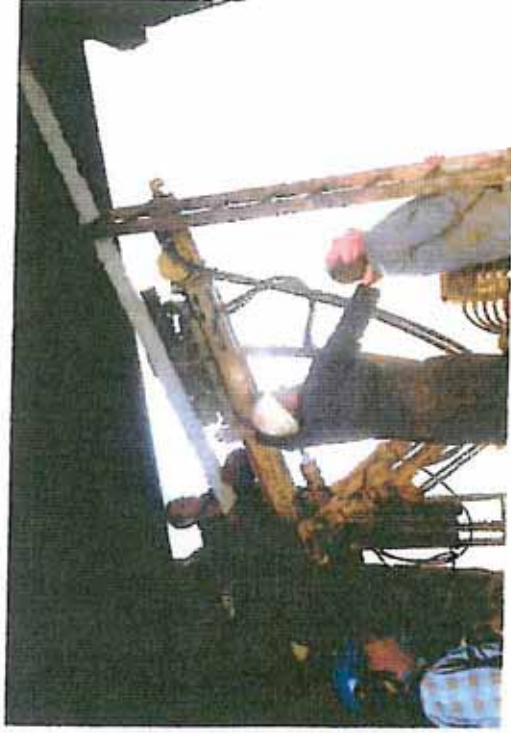
Anchor Insertion

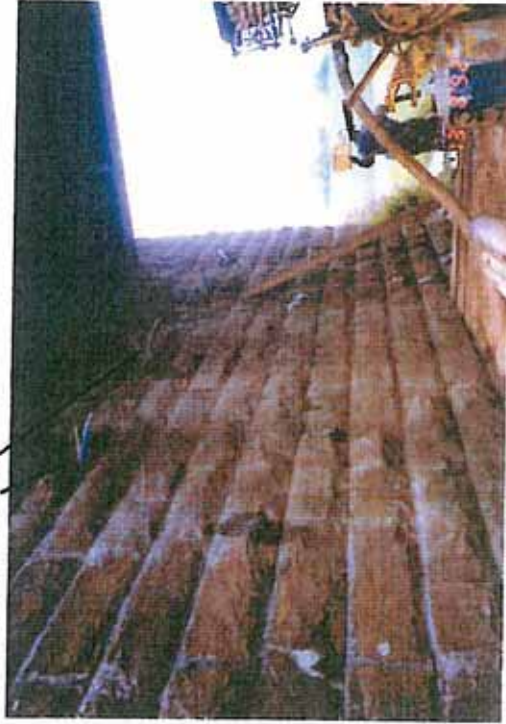
Anchor Testing

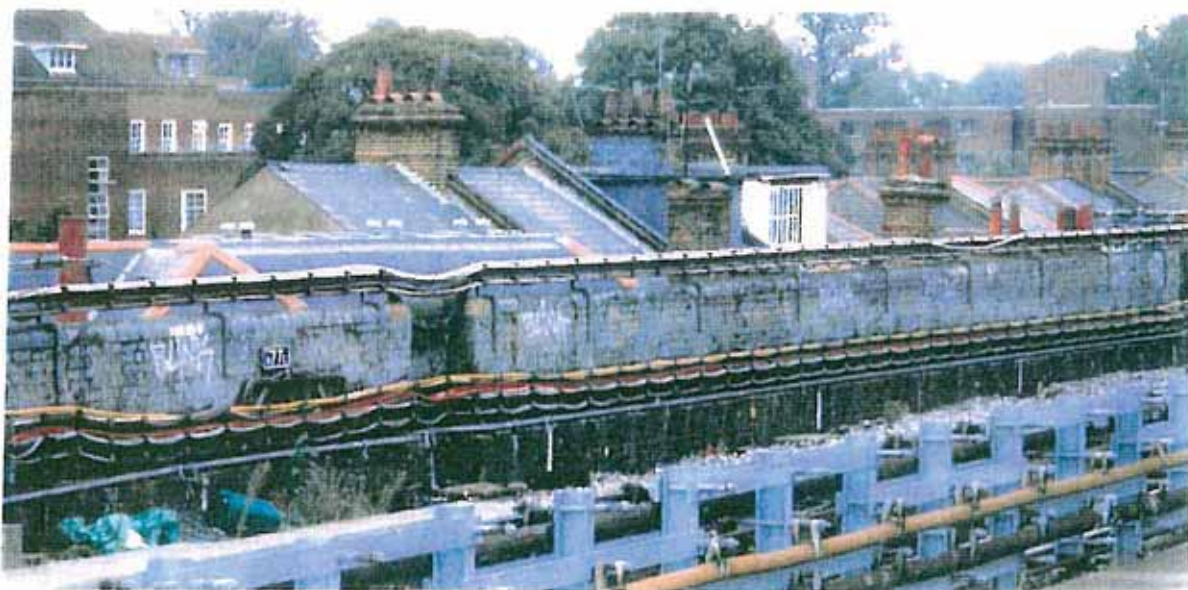
**Figure 1 Parapet wall with bolted on utilities**

The walls must be able to withstand wind loading, and where they are located beside roads or railways, there are extra windage effects caused by passing traffic. Additionally, there are traffic induced vibrations which can exacerbate the live loading and accelerate deterioration of the walls by loosening the old mortar. It is also not uncommon for walls, particularly those beside railway lines, to experience additional dead load effects due to utility pipes being bolted on, see Figure 1.

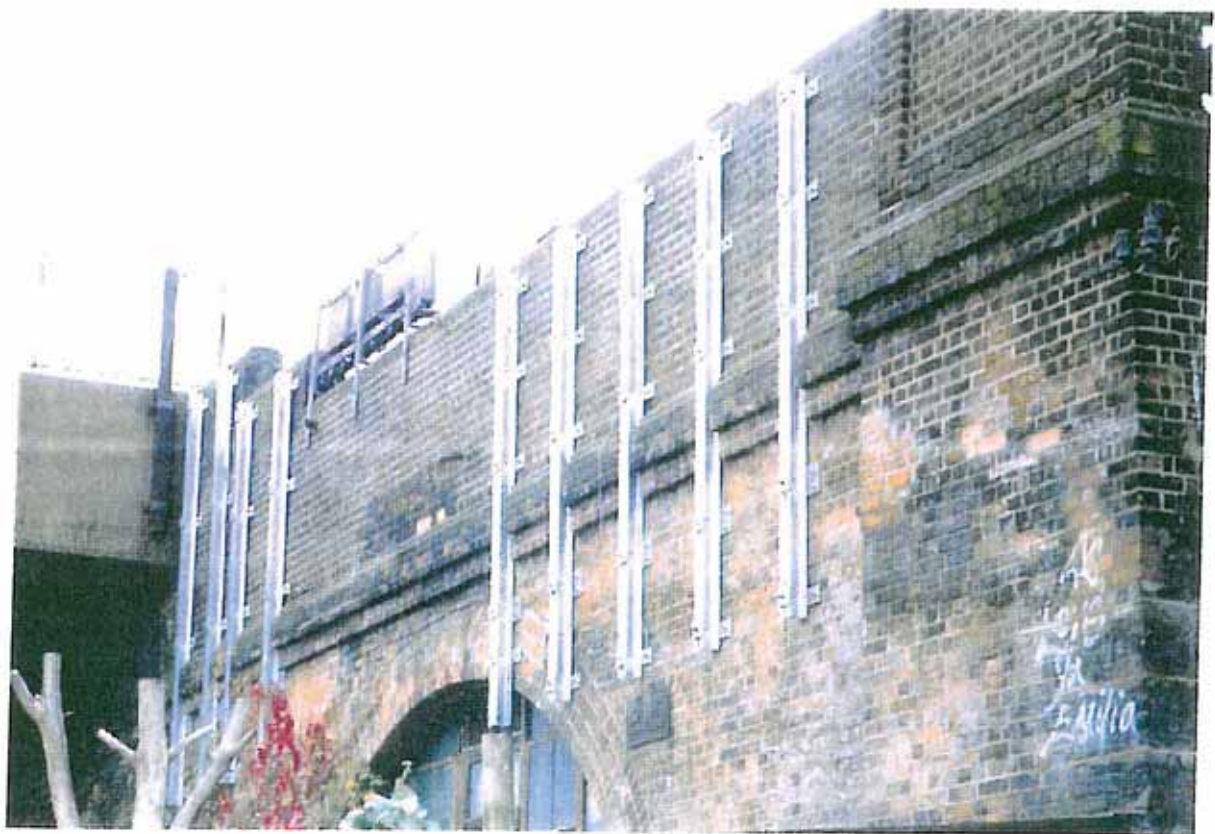
**Figure 2 Externally strengthened wall**

In situations where walls are located on top of retaining structures (a fairly common occurrence), strengthening is sometimes carried out by bolting vertical channel-section steel girders to the brickwork and retaining structure, see Figure 2. This is an unsightly method requiring regular maintenance painting and unpopular with heritage bodies. Furthermore, it is often impracticable to fit the girders when utilities are bolted to the walls.

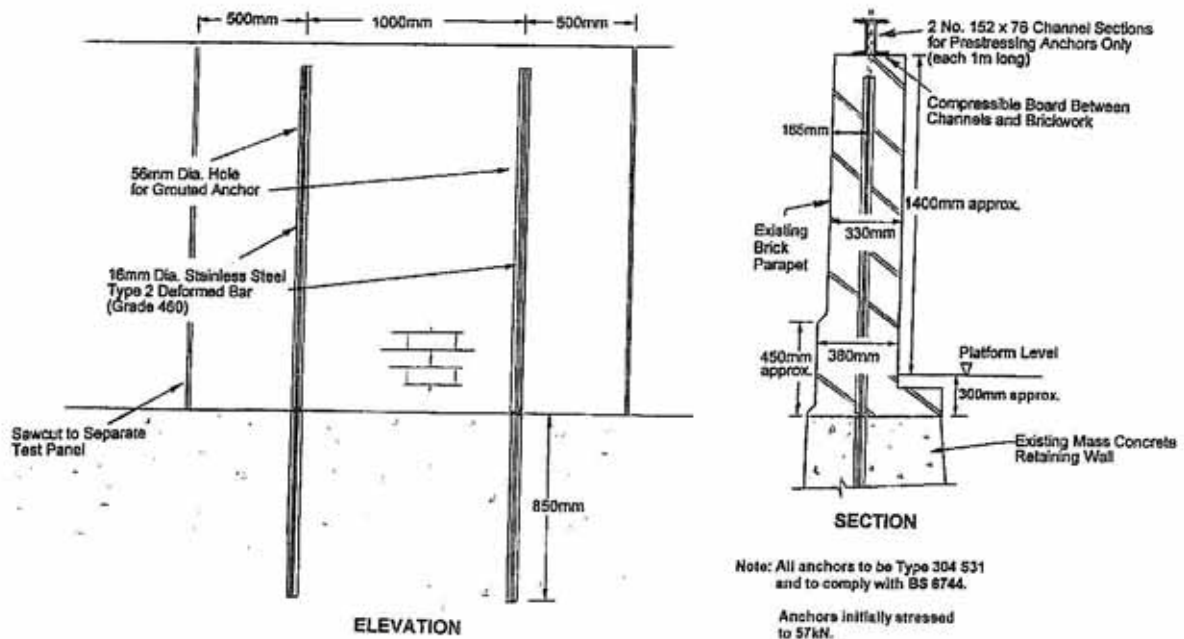
Figure 3 Details of Strengthening Scheme for Test Panel

Details of the wall together with the strengthening scheme using two 16mm diameter Cintec anchors are shown in Figure 3.

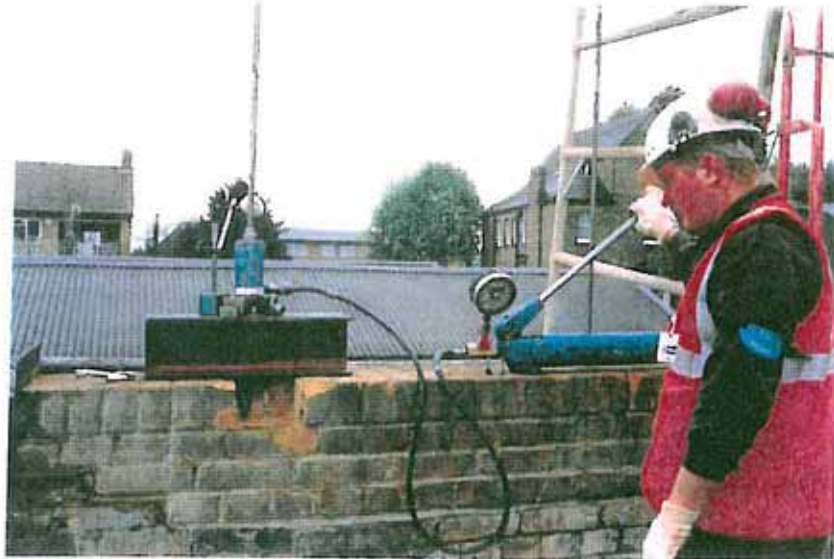
**Figure 4 Post-tensioning Anchor in Test Panel**

The vertical Cintec anchors were each tensioned up to 57kN and, during jacking, the behaviour of the wall and anchors was monitored, see Figure 4. The elongation of the anchor between the jack and the anchored end in the retaining wall was as expected. However, the wall itself was also found to compress by about 4mm at the top which was significantly greater than the 0.2mm expected. The wall was also found to deflect by about 4mm towards the platform.

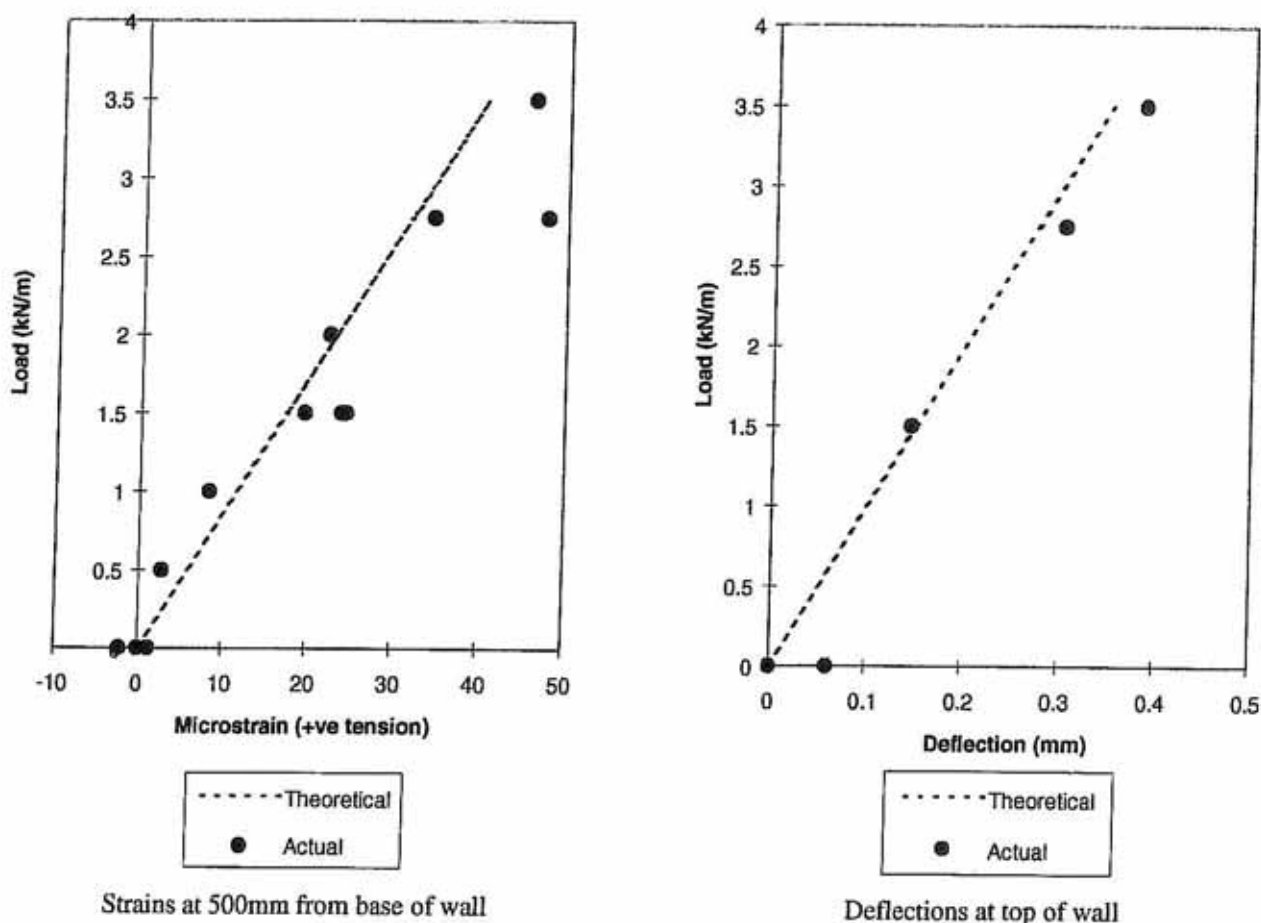
Figure 6 Comparison of Test Results against Predicted

The test results are plotted in Figure 6 against the predicted values which were based on a characteristic masonry strength  $f_k$  of 2.3N/mm<sup>2</sup> and an elastic modulus  $E$  of 2.07kN/mm<sup>2</sup> ( $=0.9f_k$ ). The measured results identified that the loading was not uniform across the full panel so, for comparison with predicted values, weighted averages were determined in proportion to the tested area. The measured results demonstrate linear behaviour but give greater strains and deflections than those predicted. This suggests that the masonry strength and/or stiffness assumed for the strengthening calculations were too high. Nevertheless, considering the possible variation of material parameters for old masonry walls, the measured results match the predicted very well.
