**CINTEC ANCHORS FOR HISTORIC
BODIAM BRIDGE**

Tim Bilson

Scoll Wilson Kirkpatrick

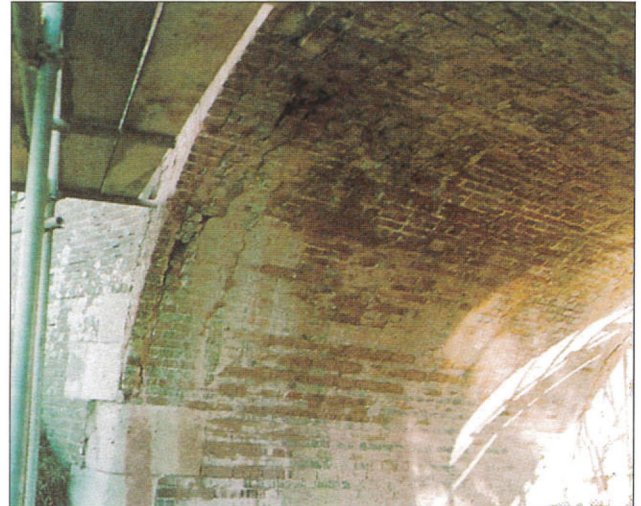
Typical damage to the soffit of the bridge

possibly impact loading towards the ends of the bridge before the 'hump' was levelled out in 1982. This impact loading will have had the effect of forcing out the spandrel walls. Frost damage during the cold winters of 1986 and 1987 and washing out of mortar have further developed the initial effects. This has led to cracking of brickwork adjacent to the arch voussoirs, some movement in the spandrel walls, and delamination of the wing walls at the south end.

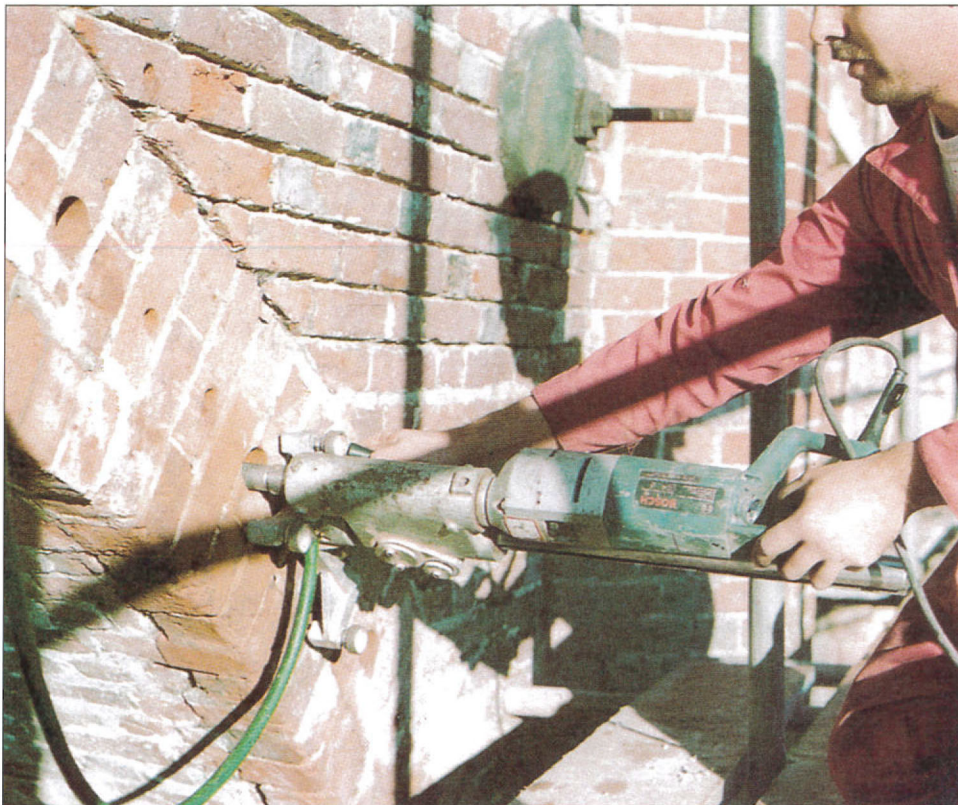
Core drilling holes for the anchors

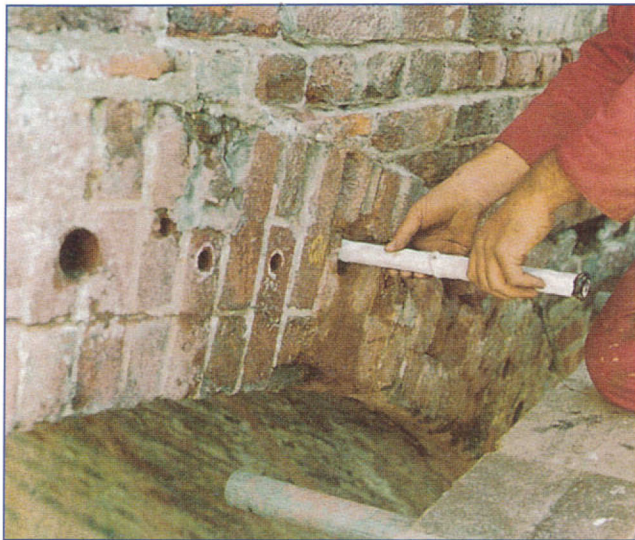
Placing the anchor in the prepared hole

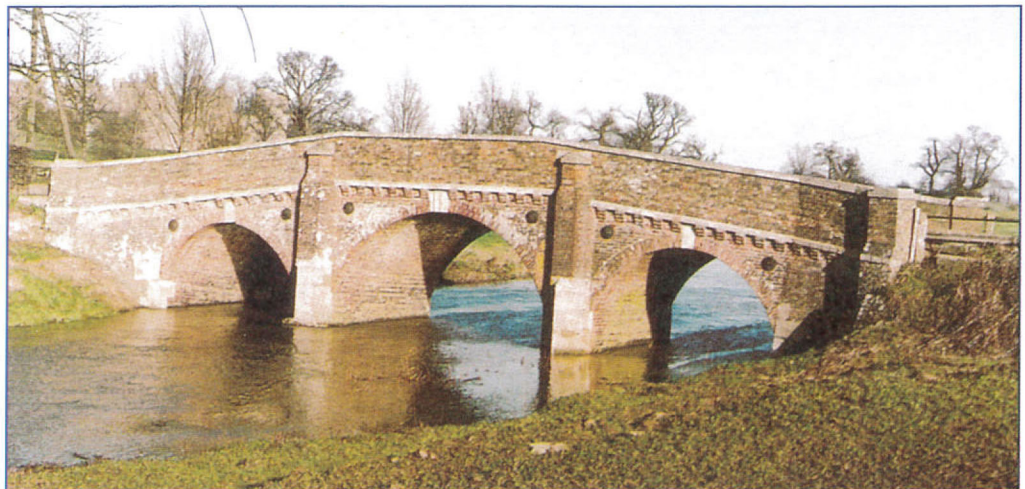
Bodiam bridge after completion with the castle behind the trees in the background.

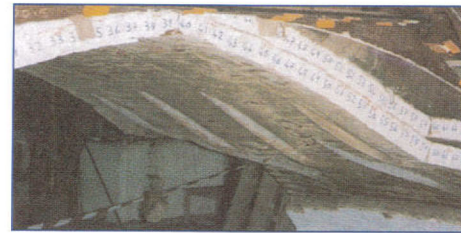
The conclusion of the TRL test, after a load failure point was raised to 41 tonnes. The picture clearly shows the exposed anchors retaining load-bearing capacity.
