Clifton Suspension Bridge

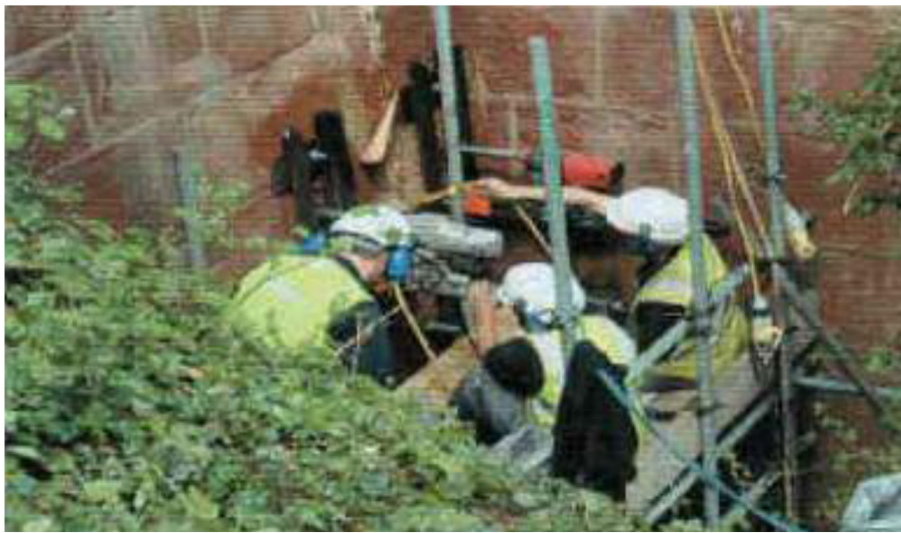
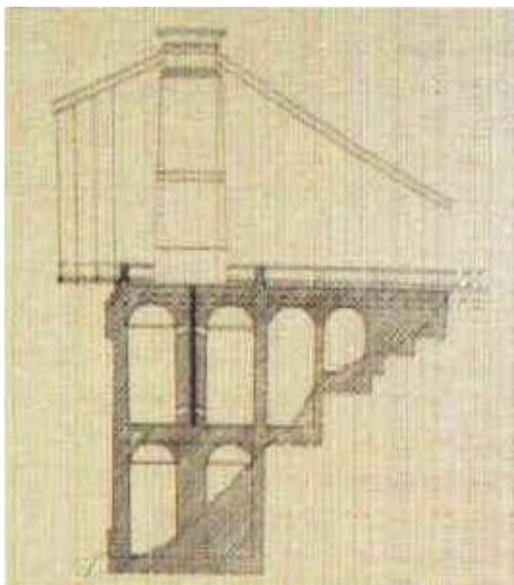
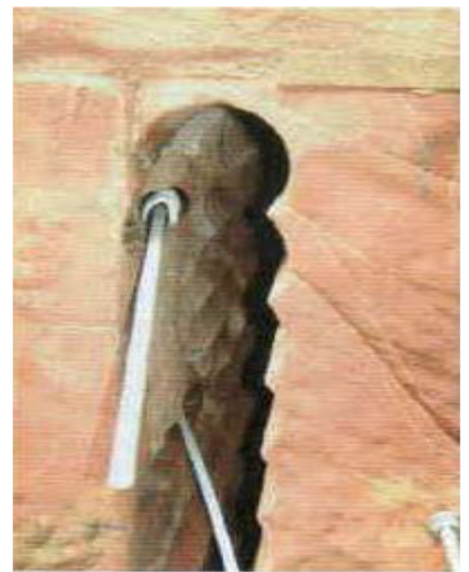
In spring 2003, work commenced to form a doorway 12m (13 yards) below the level of the footway, approximately halfway down the abutment where the wall returns to tie into the side of the gorge. The work began with the stitch drilling of 70 holes to a length of 1,800 mm(70") each with a diameter of 102mm (4") in order to create an opening approximately 2,000mm (79") high by 830mm (33") wide.

Following this, 20 CINTEC stainless steel rebar anchors were used to pin together the external and internal sandstone blocks cut through by the opening. These 16mm (5/8") diameter solid circular section anchors, measuring 1,500mm (59") long, were installed at an angle and at 300mm centers around the doorway. The anchors were inserted in 40mm (1 1/2") diameter predrilled holes, oversized to accommodate expansion of the anchor sleeve with grout. In order to maintain the aesthetics of the bridge the anchors were in set by 200mm (8") to ensure they would not be visible on the external sandstone face, achieving a sympathetic invisible bond around the new opening in the listed structure. Falcon Structural Repairs of Portishead - UK, undertook the stitch drilling and anchoring to create the new doorway, it required eight days to cut the opening and just two days to install the CINTEC anchors. The work was approved by English Heritage as well as the local planning authorities.
