PROJECT REPORT PR/CE/61/98

LOAD TEST TO FAILURE ON A RING-SEPARATED ARCH REPAIRED USING CINTEC ANCHOR SYSTEM

by S K Sumon

This report describes a load test to failure on a three-ring-brick arch bridge. The arch was constructed with a layer of wet sand between the three rings to simulate ring-separation (delamination). It was then strengthened using the CINTEC Anchor System. The test was carried out to find out the increase in load bearing capacity of the strengthened arch bridge.

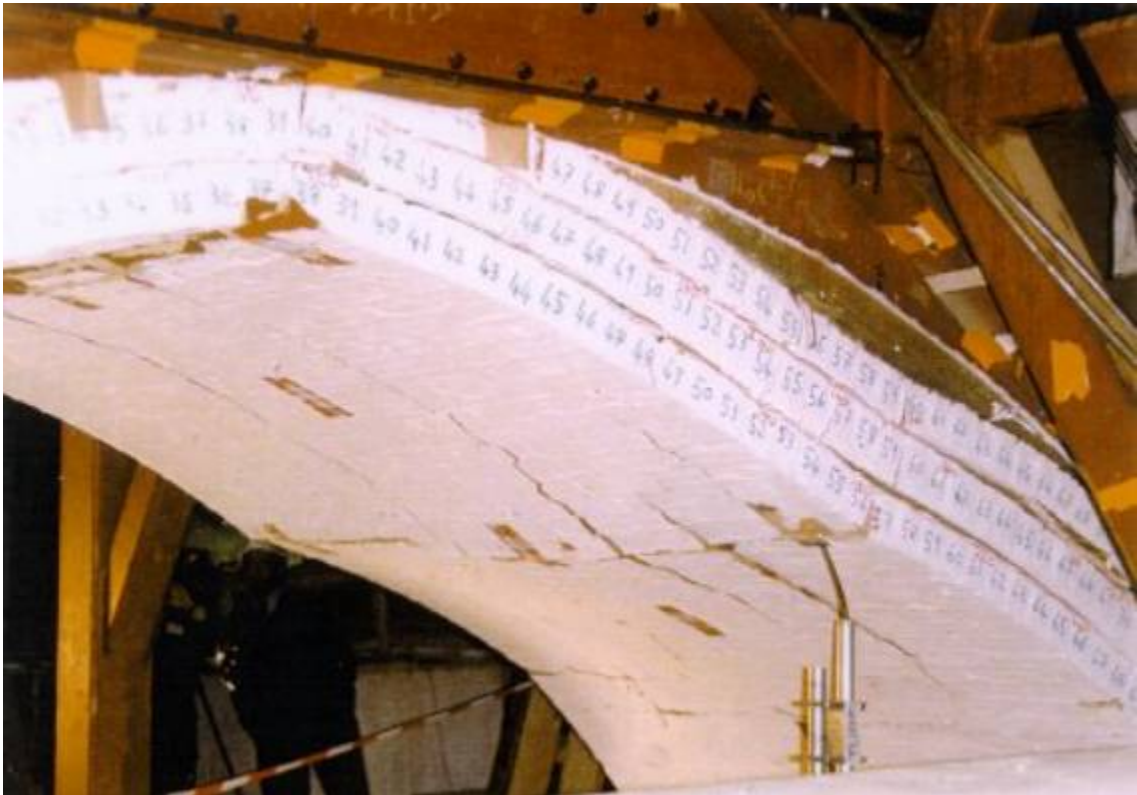
Figure 5: Arch just before bottom ring fell away

The arch was then loaded to collapse. It was difficult to maintain the applied load once the maximum load of 365 kN had been reached. Here the load could not be increased further as the structure had been considerably damaged during the test to failure. The arch was being pushed down at the load-line and up at the crown, and breaking up internally as indicated by the rapid dropping of load. At this point the loading system was switched over to displacement control. Following this as the displacement was increased the bottom ring started to crush at the crown. There was also high level of creep and plastic deformation taking place. This led to the bottom ring falling away from the structure (the load at this point was only 11.50 kN), but the rest of the arch remained held together by anchors. Figure 5 and 6 shows the arch just before and just after the bottom ring fell away. This shows the exposed anchors, under the load-line, although considerably bent they are still holding the structure together.

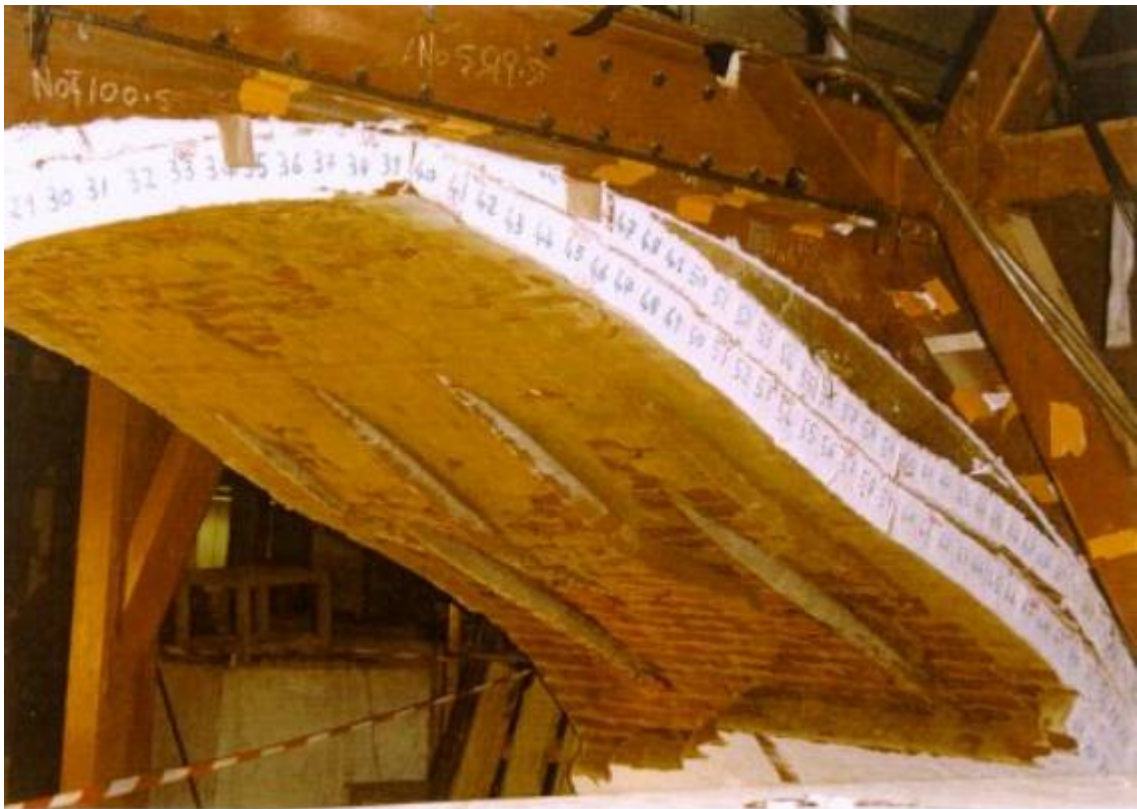
Figure 6: Arch after bottom ring fell away
