## Case History

## Teviot Viaduct, Roxburgh U.K.

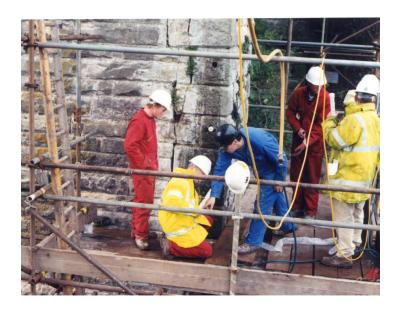
The second phase of work involved interlocking the outer masonry walls of each pier. The original design drawings and the photograph (below and right) reveal the extent of the cracking and the subsequent Cintec solution. In total 112 anchors were installed.

The first phase of restoration involved the replacement of broken and missing voissoir stones from the arch barrels. In order to reduce the risk of a progressive collapse, neighbouring stones were held in position by square hollow section stitching anchors 4'6" in length, this consolidated the arch while the replacement stones were installed.
