CINTEC

DESIGNED ANCHOR SYSTEMS

Structural repair solutions
for stabilisation & conservation

**Structural Repair,
Stabilisation &
Conservation System**

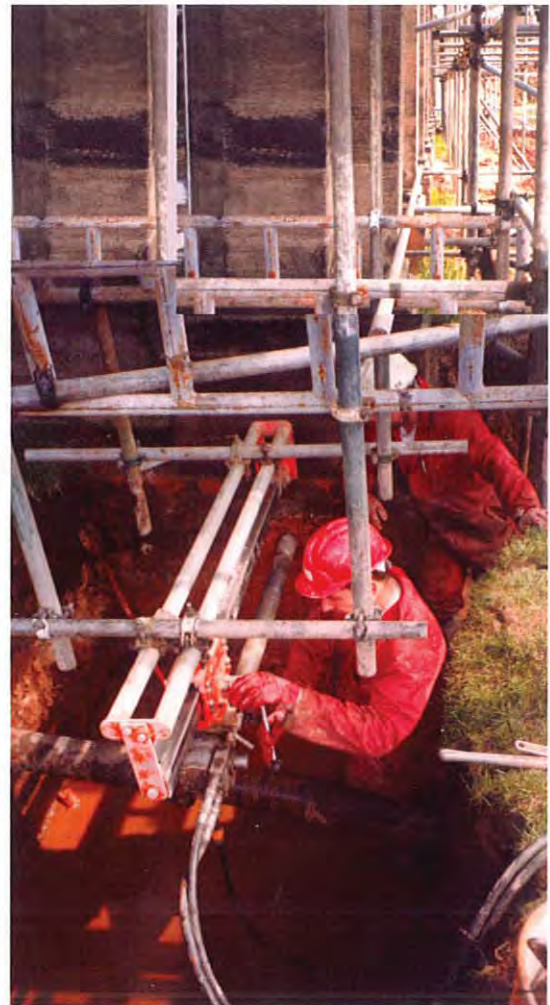
End elevation of Stoneleigh Abbey with the typical signs of differential movement due to foundation problems. A large crack is seen at the top right hand side of the gable wall running almost vertically onto the top of the circular window. The first solution was to underpin and stabilise the foundation movement. The next step was to stitch and hold the distressed walls where there was maximum movement.

The diamond drilling rig is being prepared and secured to the scaffolding prior to drilling for the anchors at foundation level.

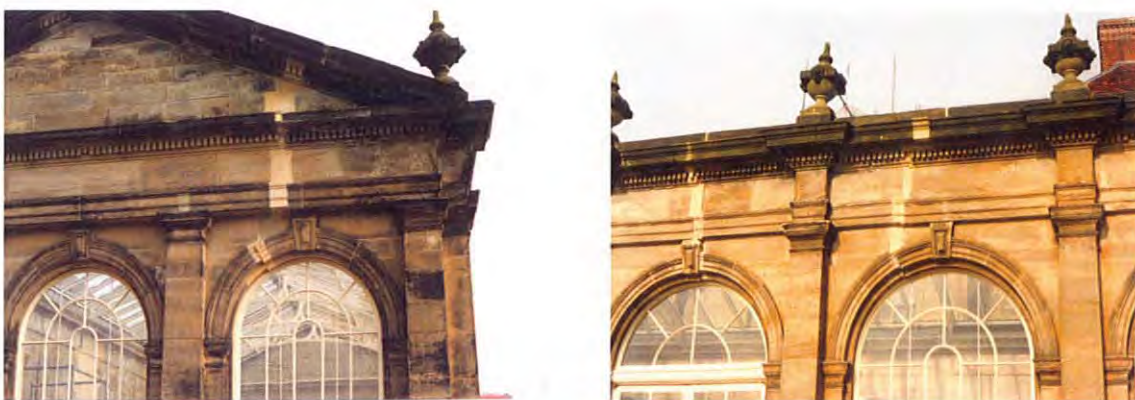
End and front elevations of Stoneleigh Abbey after all the Cintec stitching and reinforcing anchors have been installed to the external walls on four elevations. The extensive cracking was made good using matching stonework.

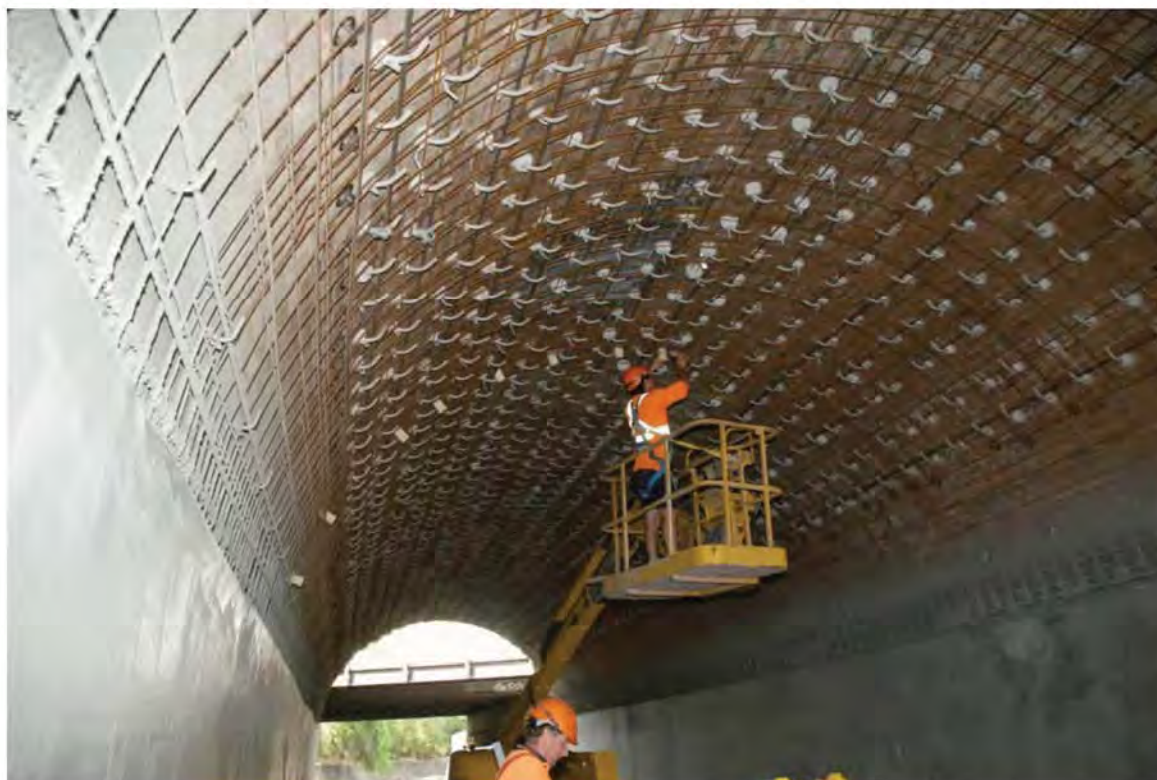
DUCK CREEK CULVERT, GRANVILLE FOR NSW RAIL CORPORATION SYDNEY , AUSTRALIA

The 6 metre span brick arch culvert at Granville in Sydney's western suburbs carries three tracks of the suburban railway system. Structural failure had occurred through overloading producing a crack along the top of the arch.

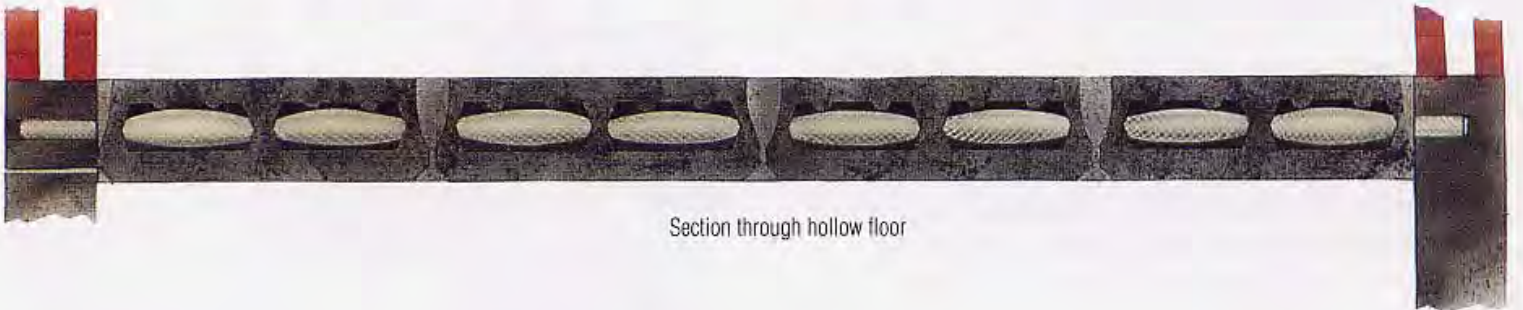
Section through hollow floor
