# ARCHTEC

strengthening,  
repair and stabilization  
of masonry arch bridges

# the Cintec System

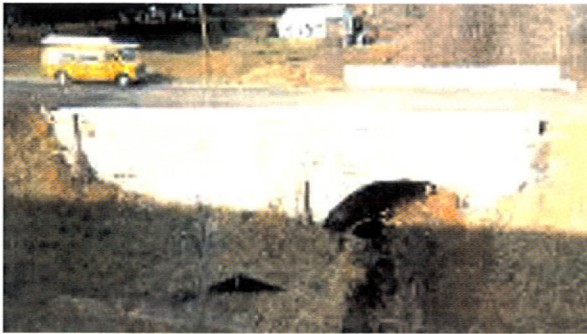
### Newcomers Mill Bridge

Newcomers Mill Bridge (route MD 733A) on the old National Highway is close to Frostberg, Garrett County in Maryland. The Bridge is one of seven remaining stone masonry bridges in the county constructed between 1813 and 1850. It is a single span masonry arch bridge over the Savage River and has significant historic value. The arch barrel is constructed from random rubble with squared voussoirs. Spandrell walls and parapets are built from roughly squared rubble.

At the time of Cintec's inspection (Nov 1999) the southern spandrel wall was in a serious state of disrepair and in imminent state of collapse.

A submission was made to Maryland State Highway Department and after the installation of over 45 Cintec Anchors, some measuring up to 28 feet (8.53m) in length, masonry repairs and low pressure grouting, this Historic bridge is once again safe.

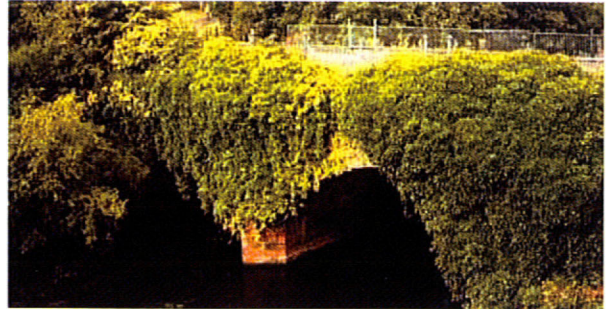
### Snowbridge

Hidden in the tranquil gardens of Kelvin Grove Park, Glasgow, Scotland, the Snowbridge was thought by many to have gracefully retired into obscurity. Its past glory of being the main means of disposing of the accumulated snow from the entire main thoroughfares of Glasgow had been superseded decades before by mechanical loaders.

With its retirement, it suffered, like most obsolete structures, with neglect and lack of maintenance due to the low priority it rated in budgets.

The scheme principally provided for the introduction of square hollow structural stainless steel anchors to the voussoirs and intrados of the arches and spandrel walls. The drilling chosen was wet diamond drilling with core retention to the natural stone structure. This provided that desired drilling accuracy and the need to reduce the vibration to a minimum in the fragile structure.

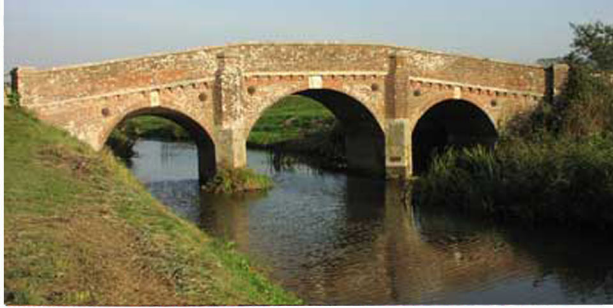
## Bodiam Bridge

The site is that of a Roman road, constructed on a twigs and rubble causeway to serve an ironworks. Built in 1797, the bridge is a single track, hump-backed triple arch structure in brickwork and there are signs of various remedial works throughout its life.

There appear to have been problems with the original construction. There is pronounced twist in the lower courses of brickwork towards the northern end of the bridge, which disappears as the construction continues upward. In recent years, the bridge has suffered from the effects of increasingly heavy traffic exacerbated by the very cold winters of 1986 and 1987. This has led to the cracking of brickwork adjacent to the arch voussoirs, some movement in the spandrel walls and delamination of the wing walls at the south end. The County Council approached Cintec for a proposal to use grout injected anchors to tie across the arch.

To prevent any further spreading of the arches, it was proposed to tie across the full width of the bridge, staggered from both sides. This ensured that the lateral stresses were not transferred to a single plane nearer the centre-line of the bridge causing new cracking at this point. Following grouting of the anchors the holes were made good with coloured mortar to match the brickwork.

Smaller anchors were also used for repair of the southern wing walls where core drilling of bulged portions of the wall showed that a half brick facing skin was delaminating from the full thickness of the wall. High bond capacity allowed an effective anchorage into a single half-brick skin, achieved while still having the end of the anchor recessed into the face.

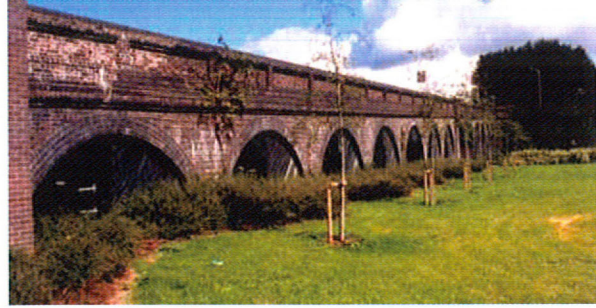
## Broxbourne Arches

The strengthening of Broxbourne Arches was carried out in January 2000. It involved work on 14 separate arches. All work had to be completed from underneath in order to avoid interfering with the road traffic on the arches. After the strengthening work, another company worked on the bridge surface to relay pipelines and upgrade the surface.

The strengthening method was designed by Gifford and Partners. Their assessment was that the crack pattern observed in the arches was not indicative of live load effects and indicated a progressive type of failure. A live load assessment had shown that the structure had sufficient capacity to carry the required live loading of 45 Tons (40 Tonnes) gross vehicle weight, and that the foundations also showed no signs of distress. Records indicated that the arches had, at some stage, been back-filled with mass concrete. While providing the arches with a substantial increase in live load capacity, the issue of thermal expansion had been overlooked. Analysis was carried out to understand the behaviour of the structure under thermal loading, and this confirmed the crack pattern observed on-site. Thermal expansion of the concrete had taken place pushing the arches laterally and producing a domino-like effect. Cracks had appeared where hinges had developed as a result of the lateral forces. Design work was then carried out to stabilize the damaged structure and provide additional capacity across the hinge positions.

The project involved the excavation of some of the ground in the immediate area of drilling to provide the angle for the insertion of the main anchors. A total of 75 Stainless Steel strengthening anchors were installed, as well as 12 transverse anchors. The project was completed in 5 weeks — the contracted period.

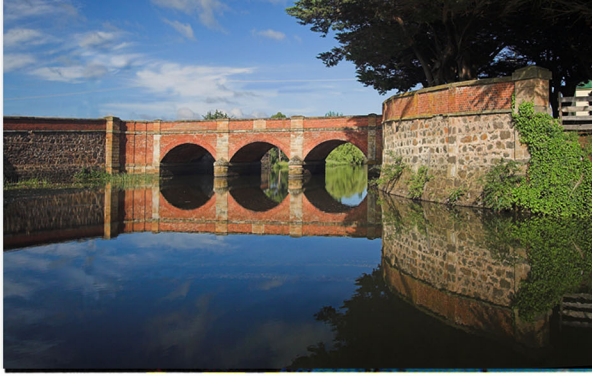
## Red Bridge

The “Red Bridge” across the Elizabeth River at Campbell Town in Tasmania is the oldest surviving brick arch bridge in Australia. It consists of three segmental arch spans of 25 feet (7.6 metres) and was built by convict labour between 1836 and 1838 using red clay bricks made on site. It rests on a basalt stone substructure and uses sandstone for the piers, abutments and cappings.

The bridge was originally built wide enough to take two modern traffic lanes, plus footways. There is presently no convenient alternative route, nor is one planned in the near future. The Tasmanian Department of Infrastructure, Energy and Resources, ordered a restoration to structural integrity and strengthening to take modern heavy vehicles. Part of the “wish list” also required strengthening to the new SM1600 loading which allows for future increases and has loads in excess of 40 Tons (36 tonnes) on a 3-axle group.

A consortium was formed by the Cintec Australian arm with Van Ek Contracting of Tasmania who are known for their expertise in conservation of old bridges and the building of new ones. When expressions of interest were called from all over Australia for a design and construct contract, only the Cintec consortium using the Archtec process was able to satisfy the Department and a contract was negotiated without further tendering.

Analysis by the Archtec consultants, Gifford and Partners of England, has shown that the bridge could be strengthened to the required SM1600 loading. Specially formulated lime grouts and mortars were used to ensure that the bridge meets the specification requirement for the foreseeable future without major repairs.

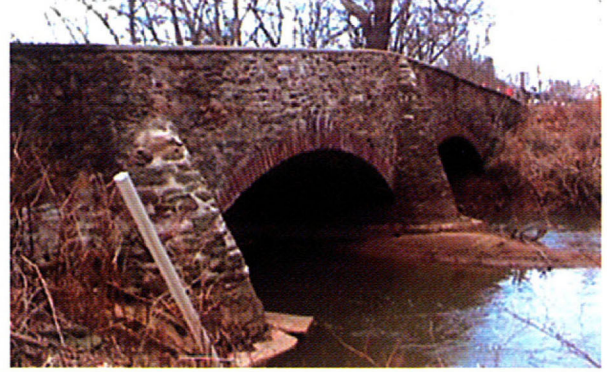
## Aldie Bridge

This historic 180-year-old stone arch bridge which carries Route 50 over the Little River in Aldie, Virginia, was found to require sensitive masonry restoration and structural strengthening after a statewide bridge survey.

Built originally for horse and buggy traffic, Aldie Bridge carries thousands of vehicles each day. The bridge is 23 Feet (7m) wide and with two single lanes and there are no sidewalks or curbs. The stone arches have spans of approximately 31 feet (9.45m) and a rise and fall of about 5 feet (1.52m).

The Virginia Department of Transportation (VDOT) concluded that the increased traffic volume and vehicle weights from local development along Route 50 caused the bridge to show many signs of being overloaded, which accelerated the normal failure mechanisms of the structure.

One wing and spandrel wall bowed out dangerously and a support buttress was showing signs of accelerated weathering due to mortar joint deterioration throughout the bridge.

Utilizing finite element computer modeling and simulation software, Cintec America calculated all of the stress factors placed on the bridge with and without the addition of customized Cintec Structural Anchors. After analysis of these results, placement of Archtec Reinforcement Anchors were designed so that the bridge would conform to federal AASHTO standards.

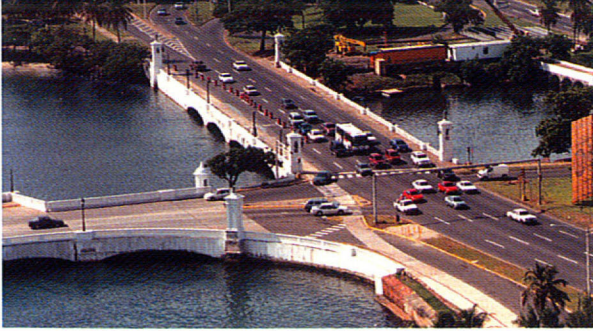
## Puente Laguna Condado

The Puente Laguna Condado is one of the principal entrances to San Juan Puerto Rico. It is a multiple span steel girder bridge built in 1926.

It was determined in 1997 that deterioration of the bridge structure due to exposure to the marine environment had weakened the bridge to the point where it was declared unsafe for the rated load. It was not possible to de-rate the loading due to the heavy traffic volume at this location.

As an emergency measure, steel seat brackets were installed under each beam. These seat brackets were connected to the historic concrete piers with Cintec Anchors.

- the condition of the concrete in the piers was not good and the oversized bearing of the grout in the Cintec sock provided a superior bearing area on the concrete.
- The oversized holes allowed for adjustments in the alignment of the anchors if obstacles such as rebar were encountered during drilling of the holes.
- the Cintec grout material is compatible with the original cementitious material in the piers.
- The Cintec Anchor system is very resistant to corrosion and fire.
- the Cintec Anchors can be installed in wet environments (even underwater) and where the substrate is salt laden.

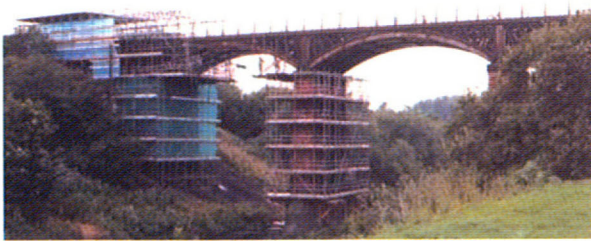
### Outwood Viaduct

Following its closure in 1966, Outwood Viaduct had fallen into dereliction. However, its proposed demolition by British Rail was forestalled due to public objection led by the Railway Heritage Trust and it was eventually given Grade II listed status. It spans the river Irwell at the western edge of Radcliffe, Greater Manchester. The spans were fabricated and erected in 1881 and have an overall length of 336 Feet (102.4 m). Each span comprises six cast iron open spandrel arch ribs with lateral bracing.

British Rail had previously attempted to strengthen the four tapering brickwork pillars by adding new masonry to the original single archway piercings located in each pier. However, this new work had begun to detach from the original structure. Extensive cracking was visible between the old and the new.

Cintec supplied 108 threaded bar and rebar stitching anchors ranging from 2.5 feet (.75 m) to 30 feet (9 m) in length. These were installed through the cracks to re-connect the inner reinforcement brickwork to the original structure as indicated in the design proposal below. After renovation, Outwood Viaduct was formally opened as a footpath, bridleway and cycleway in 1999 by Sir William McAlpine, President of the Railway Heritage Trust.

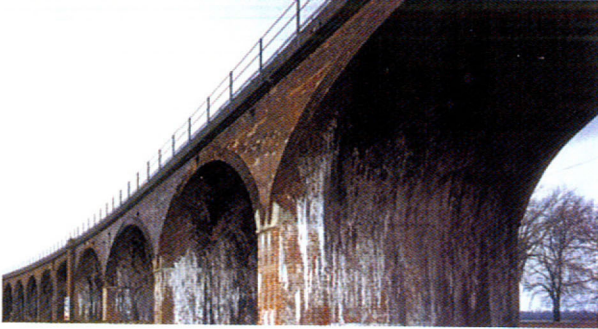
As a consequence of no longer being part of the rail system, the stone masonry structure had fallen into disrepair with extensive cracking to both the arches and the piers. A number of stone blocks had also come loose and were missing. However, because of its significance to local heritage, the viaduct was considered worthy of preservation. Funding was made available by the British Railways Board and the Railway Heritage Trust.

The first phase of restoration involved the replacement of broken and missing voissior stones from the arch barrels. In order to reduce the risk of a progressive collapse, neighbouring stones were held in position by square hollow structural stainless steel stitching anchors 4 Feet (1.22 m) in length. This consolidated the arch while the replacement stones were installed.

The second phase of work involved interlocking the outer masonry walls of each pier. In total, 112 anchors were installed.

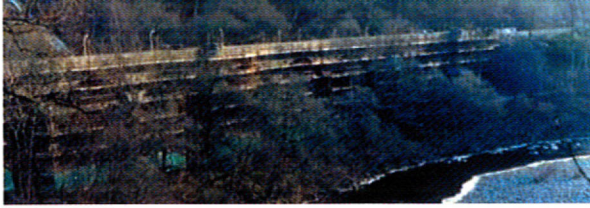
## Royal Border Bridge

As part of Railtrack's major programme of repair and refurbishment of the land-based arches, work was authorised on numbers 1-15 of the Royal Border Railway Bridge. The bridge carries the main Inter-City East Coast Rail Line between Edinburgh (Waverley Street) and London (King's Cross). George Stephenson's magnificent 28-arch, 128 feet (39m) high viaduct spans the tidal estuary of the River Tweed between Berwick and Tweedmouth, two and a half miles south of the Anglo-Scottish border. Queen Victoria and Prince Albert opened the 2160 feet (658m) long bridge in 1850; the structure celebrated its 150th anniversary at the turn of the century. The project was complicated by both environmental and technical factors.

Cintec supplied 1256 anchors spread over 15 arches and were installed horizontally through the voussoirs to varying sizes and depth, thus avoiding creating a shear line in the parent material.

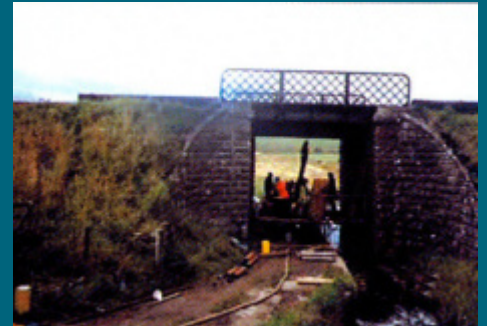
load vs. displacement test of arch model shows a dramatic increase in strength

Laboratory models of an arch bridge were constructed in brick, based on an original bridge in the UK. The load point failure point of one model was 22.5 Tons (20 tonnes). Following strengthening by single-rebar anchors, their precise location being determined by state-of-the-art design, the load failure point was raised to 46 Tons (41 tonnes.) Strengthening using newer, multi-bar anchors raised the load failure point to 50.4 Tons (45 tonnes). Overall the following results were demonstrated:

- load-bearing capacity of the arch is increased by a factor of 2.05
- the first crack or hinge does not occur under the load-line
- overall, the installed anchors delay the formation of hinges
- the bond between anchors and masonry is sound
- the strengthening is relatively easy to install
- the system demonstrates significant flexibility and increased ductility

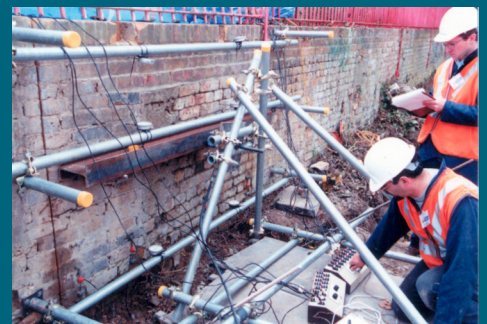
parapet walls can be strengthened at a fraction of the cost of traditional methods

The requirements specified for individual walls can differ considerably and must reconcile a variety of needs. These may include impact containment, vehicle redirection, the protection of others in the vicinity, compatibility with the masonry structure as a whole, as well as the visual appearance of the strengthening solution implemented.
