Many Engineers and Architects are astounded at the lengths Cintel will go to install long anchors over 105Ft [32m] .

Attached are a few examples: -

CASE HISTORIES WHERE AVAILABLE CAN BE FOUND AT WWW.CINTEC.COM

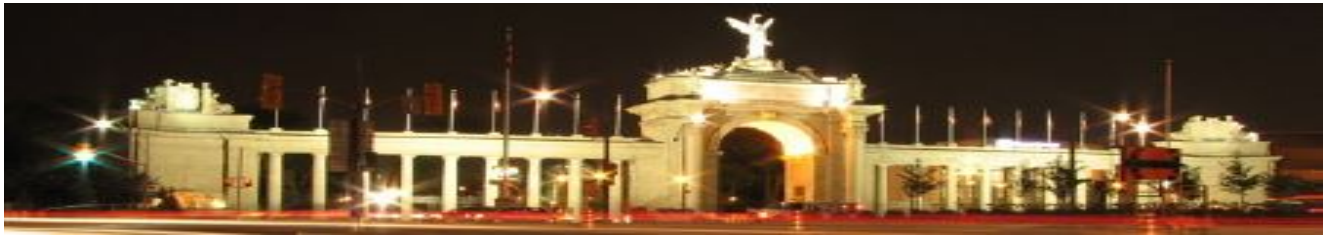
Prince's Gate, Toronto, Ontario, Canada

The gates are made of a mix of stone and concrete. There are nine pillars to either side of the main arch, representing the nine Canadian provinces in existence at the time of construction. Each column consists of several, tapering, annular rings stacked to a height of 27 feet and sit on a concrete pile cap some 7 feet thick. The project required an anchor that would extend the full depth of the column and pile cap, mechanically and adhesively tie all components together and allow post tensioning load of 25,000 pounds per column. Two stage anchors, 35 feet long were fabricated by Cintec, each comprising #9 carpenter stainless steel, 4" diameter polyester Cintec sock for the 7 foot first stage and 3 1/2" diameter sock for the second stage. The anchors were carefully lowered into place by crane and the first stage inflated using Cintec Presstec® grout. After 7 days, tension load of 25,00 lbs. was applied, bearing plate secured and the second (27 foot) stage was inflated.

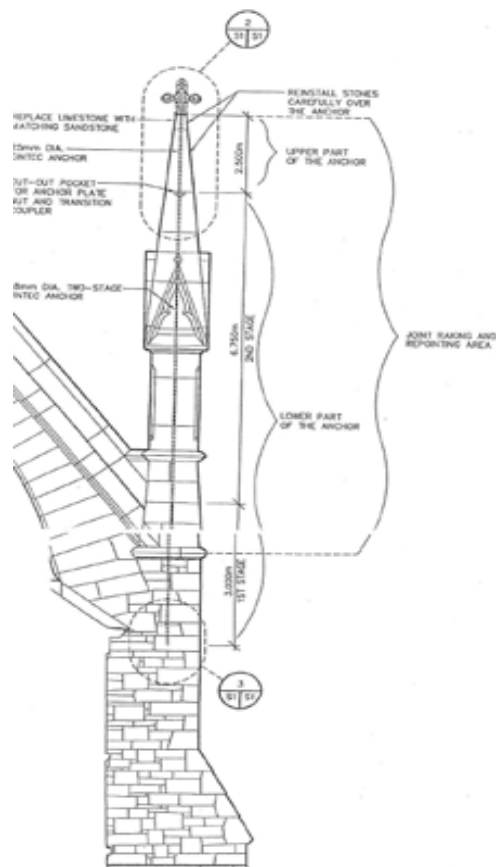
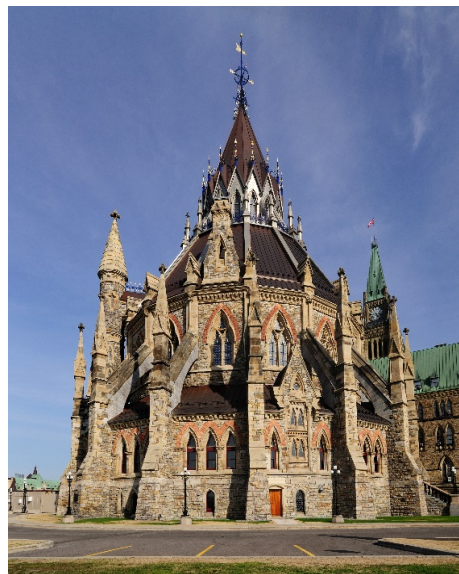
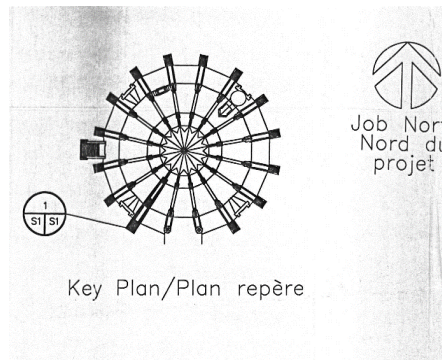
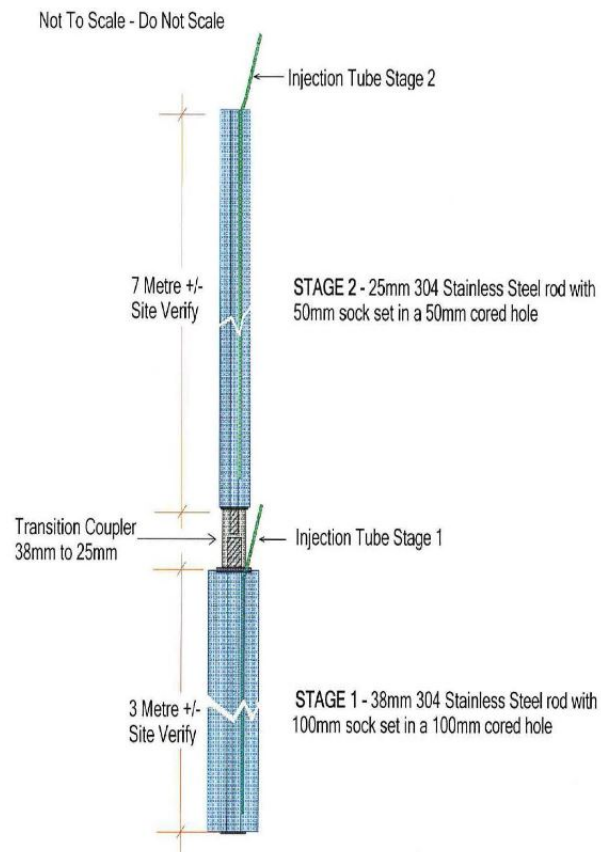
THE REINFORCEMENT & STABILISATION OF THE BUTRESS & PINNACLES WITH 2 stage post tensioned Cintec Reinforcement Anchors up to 35.5 Ft [10.8m] long

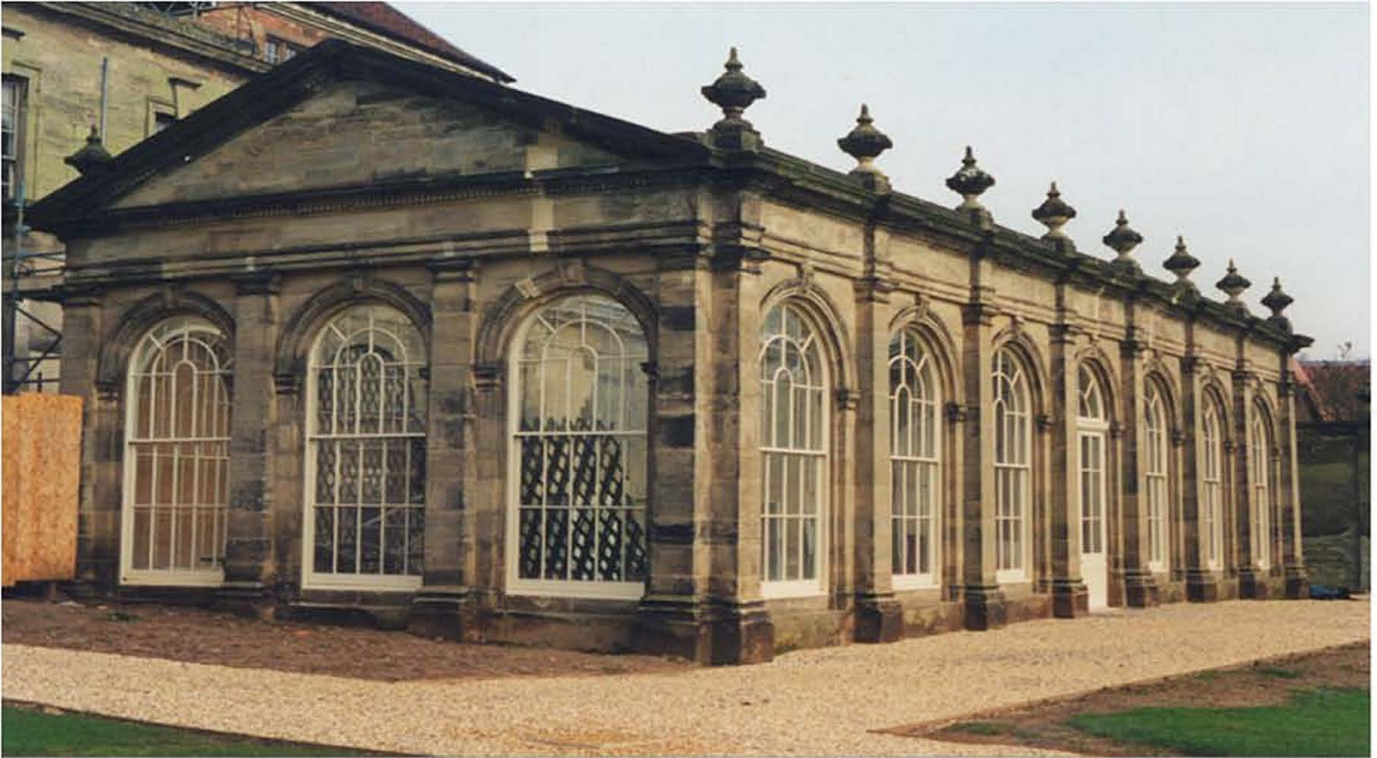
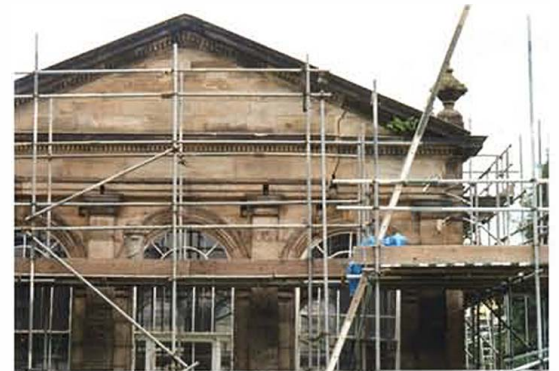
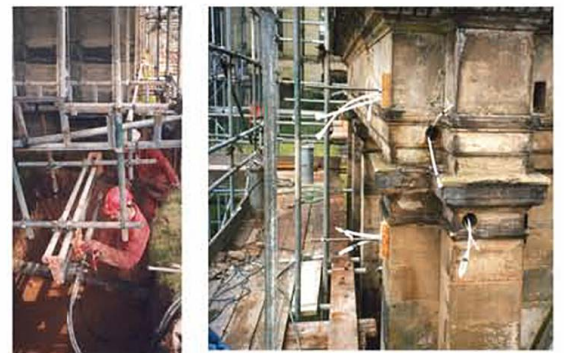
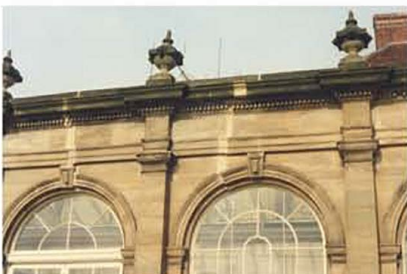
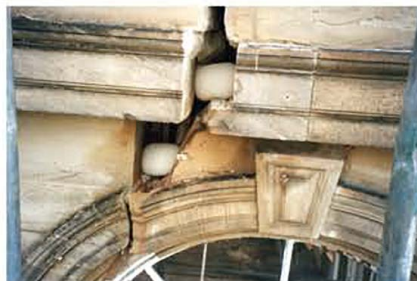
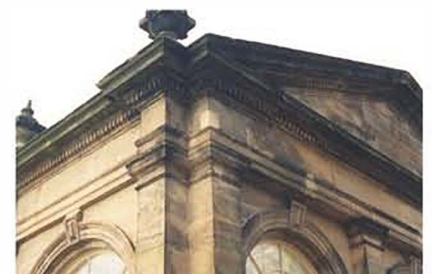
STONELEIGH ABBEY [The Orangery], Kenilworth, U.K

Stoneleigh Abbey's orangery had broken its back both on the short and long sides of the building, which measured some 22 meters [72Ft] by 9 meters [29.5Ft] the settlement being caused primarily through inadequate rainwater disposal. The cost of rebuilding the defective parts of the structure would have been enormous. It was therefore decided to keep the deformation in the structure but to stabilize it. The project Engineers, determined to use pre-tensioned Cintec anchors at foundation level and cornice level to hold the curtain walling together. One row of anchors were installed around three sides of the building at foundation level and two rows around all four sides at cornice level. The wall consisted of two skins of ashlar back to back with an irregular void running down the length of the wall. The anchors consisted of 16mm [1/2"] stainless deformed bar in a 76mm [3"] dia hole, the 22 meter [72Ft] long ones being in 2 Number 11 meter [11Ft] lengths connected onsite and pumped from both ends. Once in place the anchors had temporary end plates attached and were tensioned to 10kN, [2248.1lbf], prior to grouting. When cured the end plates were removed and the cores replaced and made good.

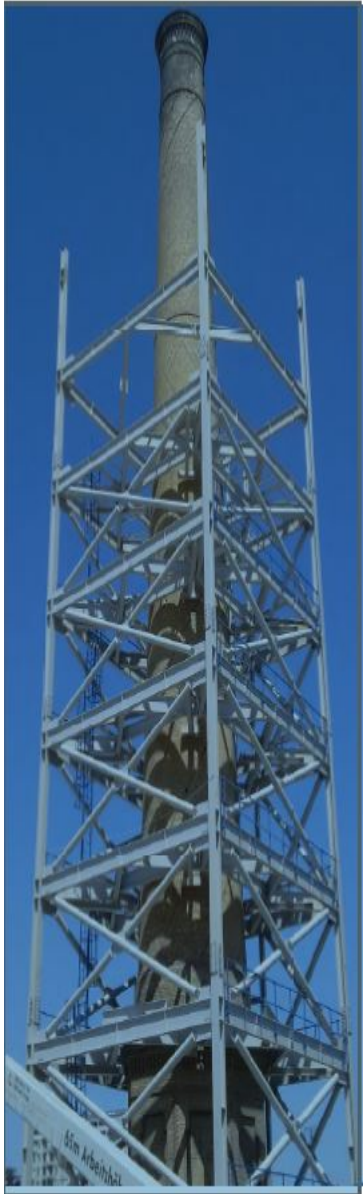
PORT BAKU 2 CHIMNEY RESTORATION AZERBAIJAN

Anchor layout and the tower scaffold which, as well as for access was designed to hold the chimney in the event of a seismic event.

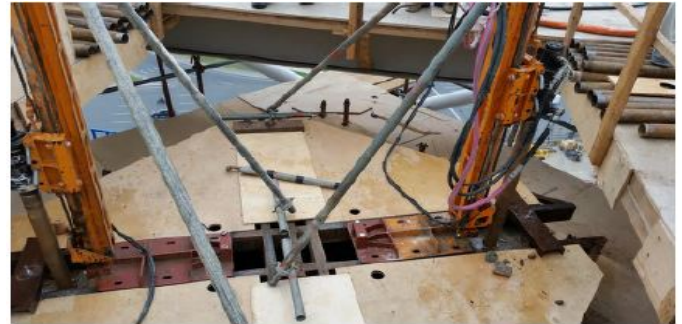
Vertical 24M [78Ft] holes 101 mm [4"] diameter were drilled, angled to suit the outside taper of the chimney.

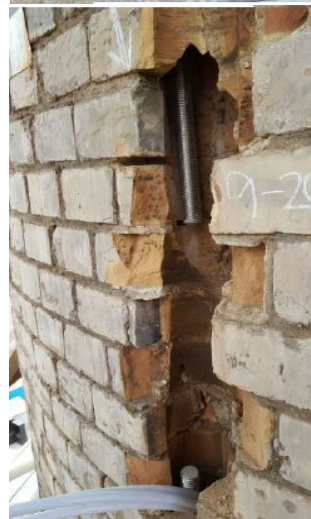
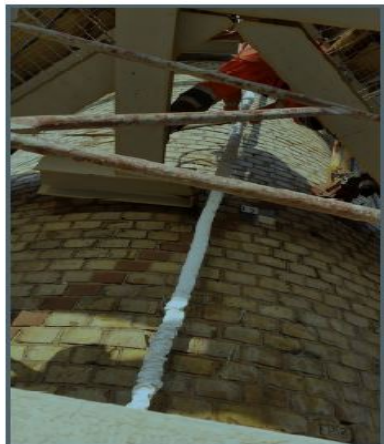
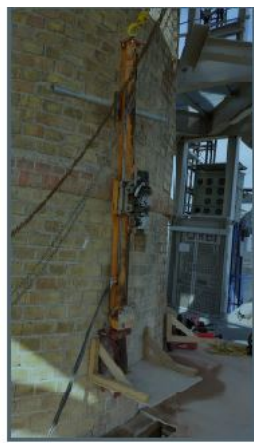
The 18M [78Ft] and 12M [39Ft] vertically inclined anchors were connected with a cranked section to create a continuous anchor.

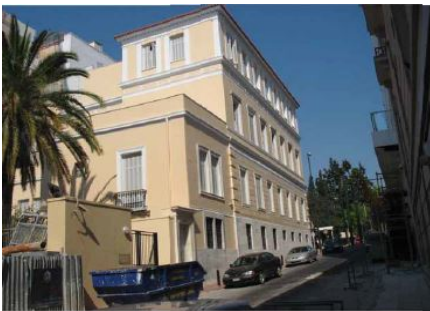
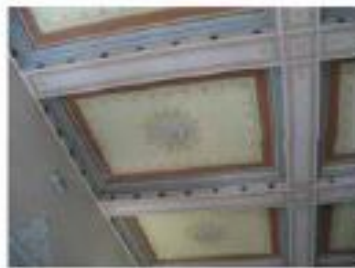
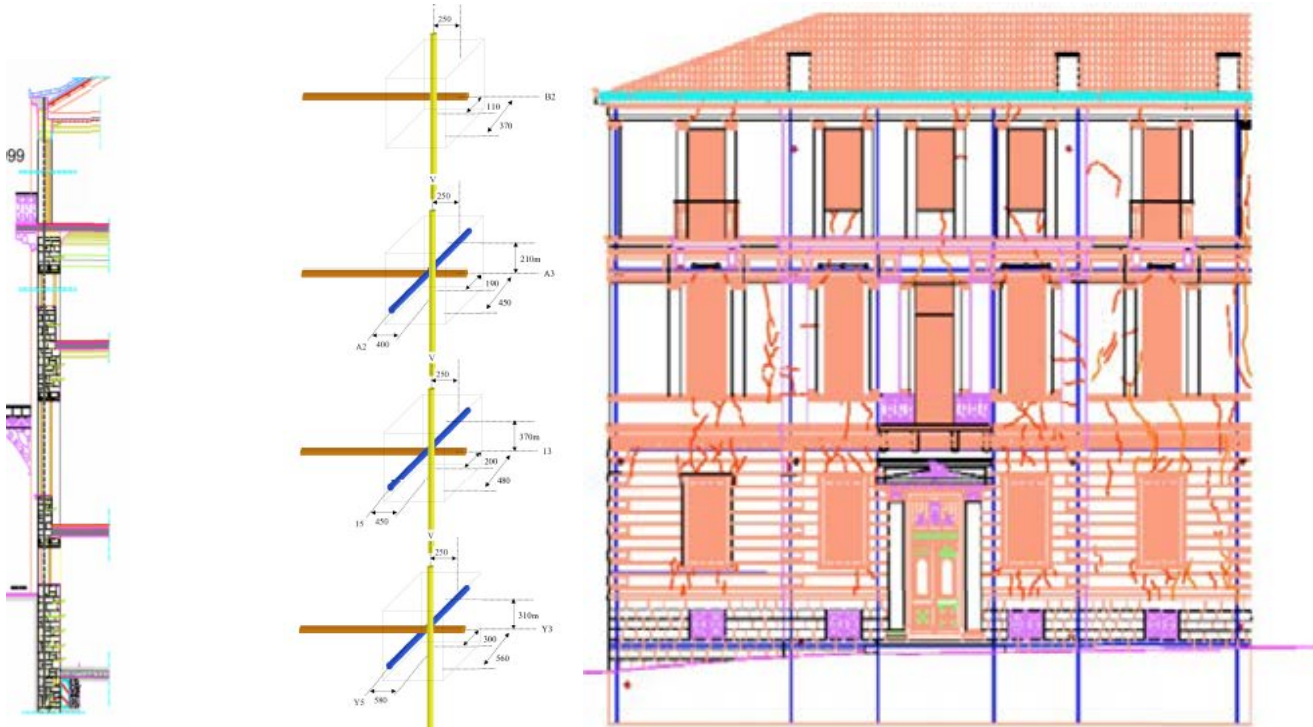
The European Parliament Athens Greece

Restoration following the Earthquake September 1999

1" [25mm] ribbed anchors at each floor level were installed, to form an internal reinforcing steel frame work. The Cintec socked system prevented grout penetrating the building through numerous cracks and damaging the ornately decorated walls and ceilings. The Cintec anchors were assembled on site in sections, to achieve lengths of 95ft [29m]

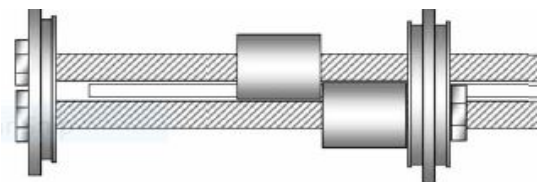
Anchor positions were carefully marked out and drilled with extreme precision to avoid intersecting anchors

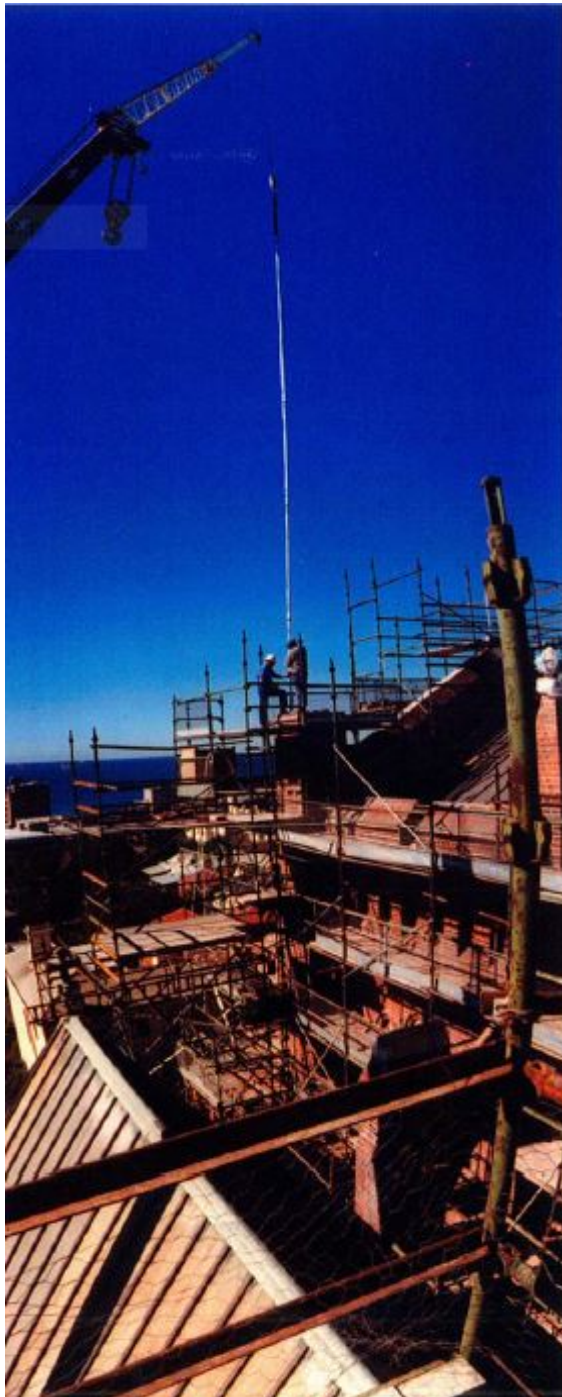
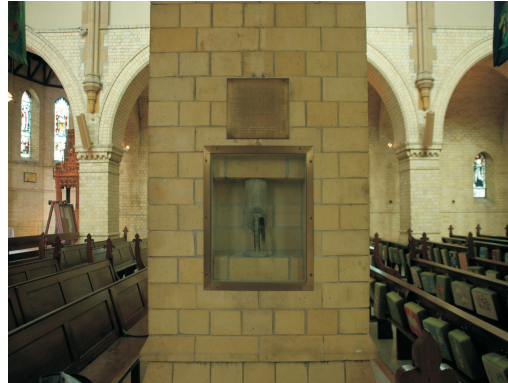
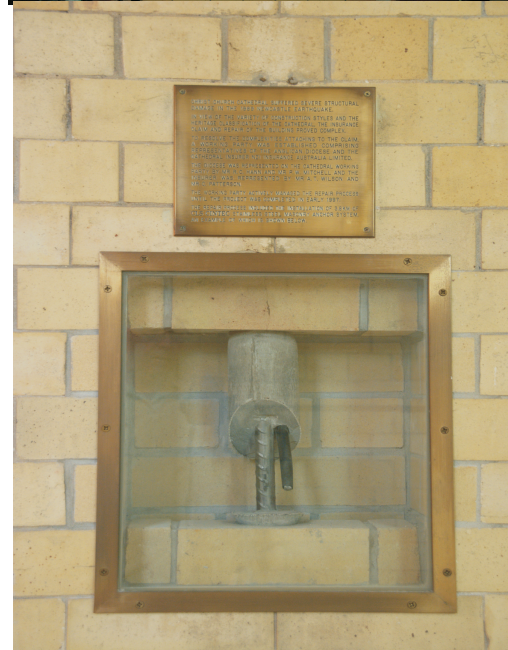
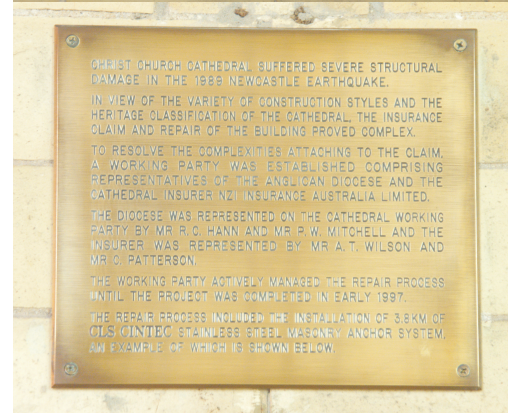
Christ Church Cathedral

Inserting one of the long anchors by crane. Internal pillar showing Cut out to expose Cintec Anchor in the middle of the pillar. The Plaque reads "CHRIST CHURCH CATHEDRAL SUFFERED SEVERE STRUCTURAL DAMAGE IN THE 1989 NEWCASTLE EARTHQUAKE. IN VIEW OF THE VARIETY OF CONSTRUCTION STYLES AND THE HERITAGE CLASSIFICATION OF THE CATHEDRAL. THE INSURANCE CLAIM AND REPAIR OF THE BUILDING PROVED COMPLEX. TO RESOLVE THE COMPLEXITIES ATTACHING TO THE CLAIM, A WORKING PARTY WAS ESTABLISHED COMPRISING REPRESENTATIVES OF THE ANGLICAN DIOCESE AND THE CATHEDRAL INSURER NZI INSURANCE AUSTRALIA LIMITED. THE DIOCESE WAS REPRESENTED BY MR R.C HANN AND MR P.W. MITCHELLE AND THE INSURER WAS REPRESENTED BY MR A.T. WILSON AND MR C.PATTERSON. THE WORKING PARTY ACTIVELY MANAGED THE REPAIR PROCESS UNTIL THE PROJECT WAS COMPLETED IN EARLY 1997. THE REPAIR PROCESS INCLUDED THE INSTALLATION OF 3.8KM (2.36M) OF CLS CINTEC STAINLESS STEEL MASONRY ANCHOR SYSTEM. AN EXAMPLE OF WHICH IS SHOWN BELOW." Cintec M32 [1 1/4" or 32mm] Dia 316 stainless steel deformed bar at 105 Ft [32m] long.

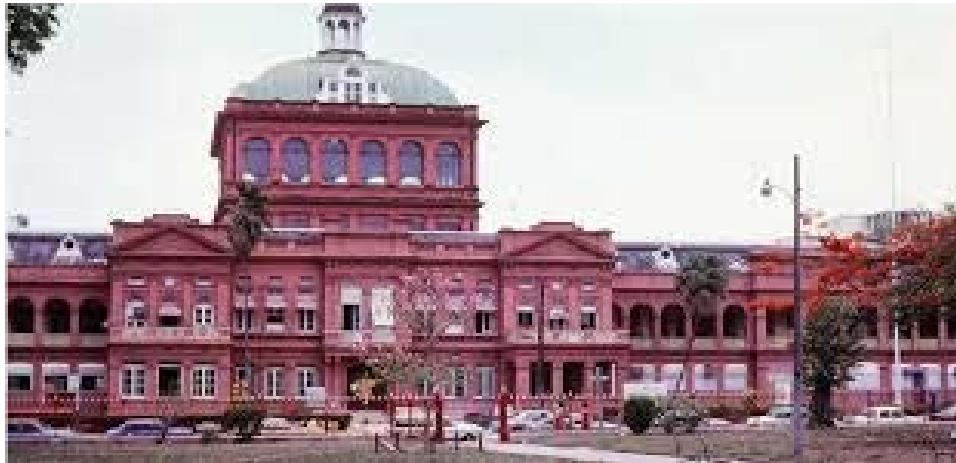
The RED HOUSE, Parliament Buildings, Trinidad & Tobago

Structural Seismic Retrofit

The Red House is the seat of the Parliament for the republic of Trinidad & Tobago. The architectural design is of the Beaux-Arts style. The original building, never completed, was built between 1844 and 1892. Painted Red, hence its name, was severely damaged by fire in March 1903. Rebuilding / Refurbishment started in 1904 on the same site and was opened in 1907. Cintec were asked to provide information to Genivar (now known as W.S.P) and C.E.P as far back as 2007. Strengthening work to the Red House finally started in 2017. Cintec provided additional specialist training and long reinforcement bars to ensure, as far as possible, that there would be no long hole drilling problems on this very important Historic project. These trials determined the positioning of the drill; it was calculated that deliberately pointing the drill up 0.50 degrees should compensate for the force of gravity pulling down the core barrel over 38m/ 125 ft.in length. This proved to be very effective, as the drill exited at the other end of the beam exactly as predicted vertically and only 50mm/1.968inch out on the horizontal. These Long anchors are on the second floor of the building through a beam that is only about 1.0m square. Accuracy is critical: misalignment by one degree would result in the drill exiting the side of the beam within 20m/65.5ft. of the starting point.

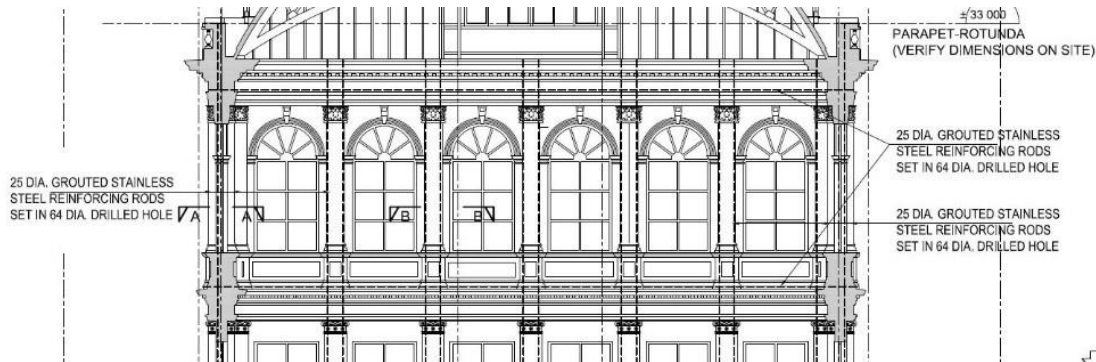
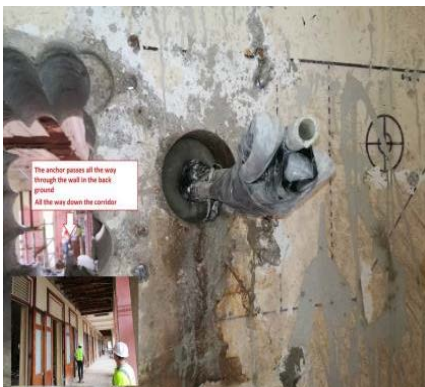
On this project for the first time Cintec has used computer 3D printed parts and Cintec's longest anchor to-date, at 120 ft. / 36.52m has been successfully installed

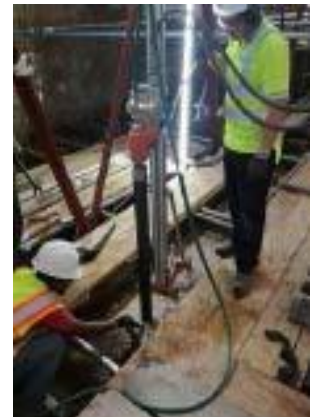
TYPE 1: Cintec No 8 Rebar 2205 (1" Dia) Reinforcement

REINFORCEMENT LENGTH TO SUIT SITE CONDITIONS
 Client To Confirm ALL Measurements Before Ordering By Site Inspection
