# PORT DE QUEBEC

# ‘Stitching up’ the past – The strengthening of three heritage marine structures in Jersey with needling technology

# WWII sea wall in St Aubin's Bay, Jersey: infrastructure improvements to alleviate flooding

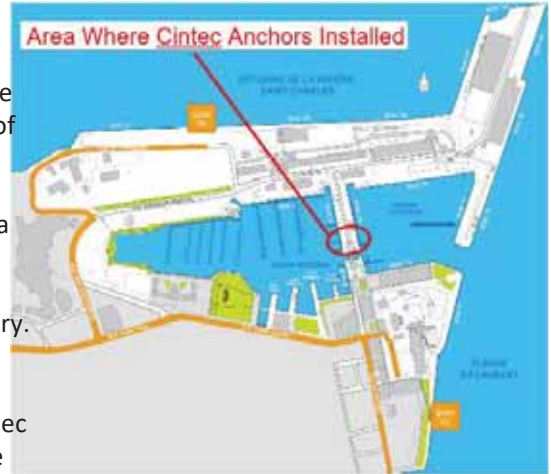
The requirement was for vertical strengthening in two areas of Quai 5-14N of the Port of Quebec as shown in top photos. As determined, anchors were to be a 1 1/4" diameter, #30M 2205 stainless steel reinforcing bar with overall anchor lengths of 25 feet (7.5M) to 30 feet (9 M) long. 48 anchors were fitted with 4 inch (100 mm) sock and installed by use of a crane in drilled cored holes of matching diameter. Placement completed by injection of Presstec © grout.

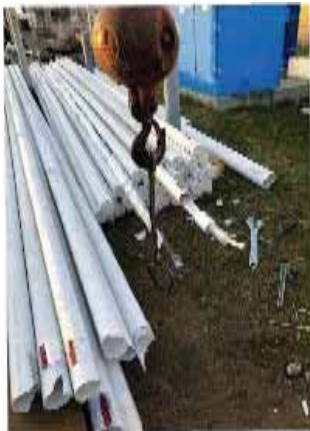
Cintec anchors in protective shipping tubes

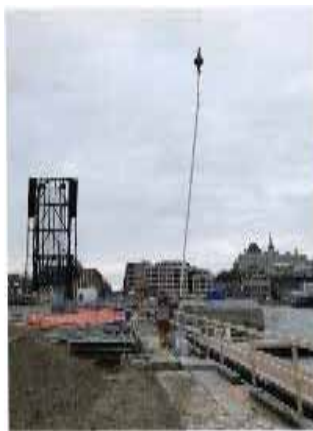
Cintec anchors hoisted into place by crane

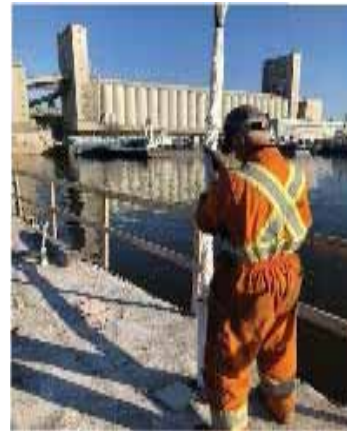
Cintec anchors being placed by installer

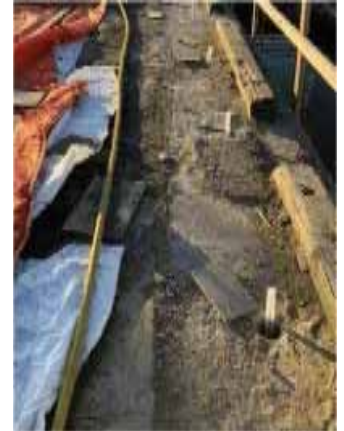
Cintec anchors in place prior to inflation

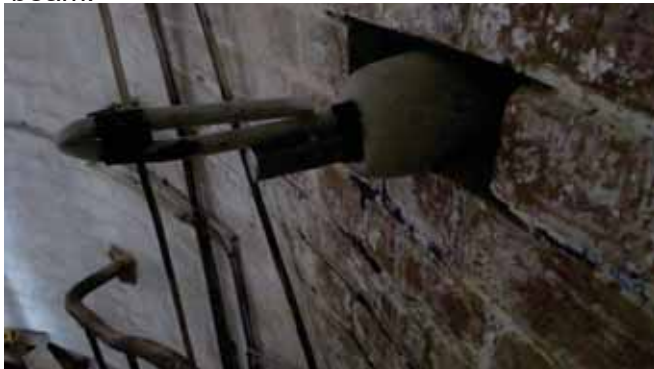
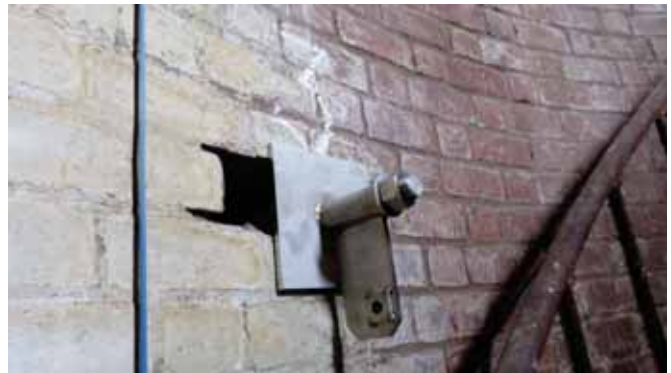
The stabilization on the stair case included the installation of CINTEC CEMENTITIOUS GROUT ANCHORS. The anchors were tied to the inner and outer walls of the lighthouse. A beam was tied to the anchors. The staircase was tied to the beam to support it. CINTEC AMERICA provided the anchor system to support the staircase. ICC- COMMONWEALTH based in Buffalo, NY were responsible for the Engineering and installation.

Project Anchor specification was 1 3/8" (35mm) dia Stainless Steel rebar grade 2205 - 44" (1118mm) long socked 41" (1040mm) with 3" (75mm) of exposed threads to attach bracket to beam.

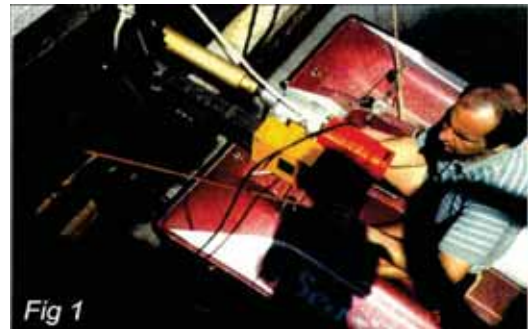
Consisting of a steel rod enclosed in a mesh fabric sleeve, the principle of the system is to inject a specially developed cementitious grout into the restraining sleeve of the anchor and so inflate it along its entire length. As well as providing an extremely strong mechanical bond, some liquid or 'grout milk' passes through the material membrane and bonds with the original substrate beyond.

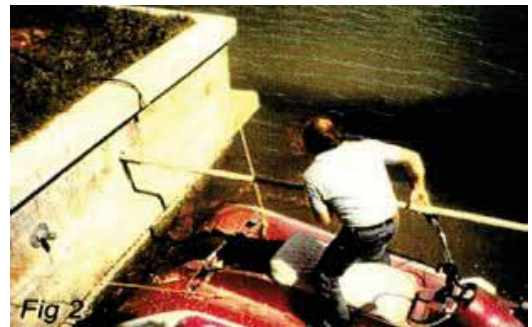
In the case of Marco Island, an additional wide section of expandable sleeve, or sock as it is often called, was attached to the far end of the anchor. When the grout was injected, the additional section expanded to a diameter greater than the rest of the anchor. This created a bulb deep within the soil and ensured a truly secure point of anchorage.

As can be seen in the images (right) the individual boreholes were produced by diamond core drilling, in this case with a core diameter of 65mm (2 ½") and to the length of the anchor : 3.2 meters (15ft) – Fig 1. The anchors were then installed with a plastic half pipe to facilitate their insertion – Fig 2. Finally the anchors were injected with 'presstec' cementitious grout expanding them from their far end to the front. Although not essential, a flange – plate was also screwed to the exposed anchor end for additional securement – Fig 3.

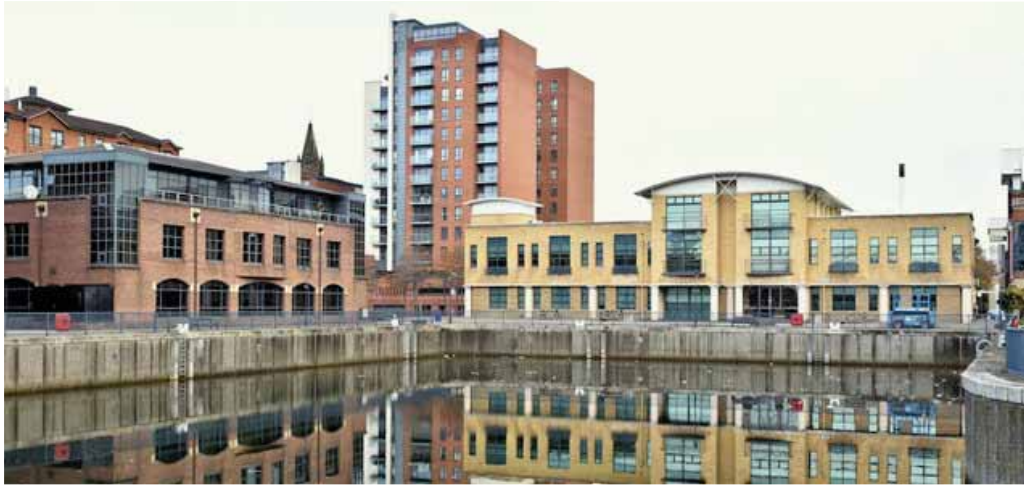
Cintec anchors have been used to fix two 20 ton lock gates, as part of the 750 million pounds sterling, regeneration of Belfast's Laganside Development.

Each gate is supported by two hinges bolted into the 600mm concrete wall of the lock. One of the key reasons for selecting the Cintec system, was that although the top hinge for each gate is well above the water level, the lower hinge falls within the tidal zone, "explained Brian Campbell. Design engineer for the installers. During the installation, sea-water poured through at one of the anchor locations. We were concerned that alternative fixing methods would not be as successful in such wet conditions."

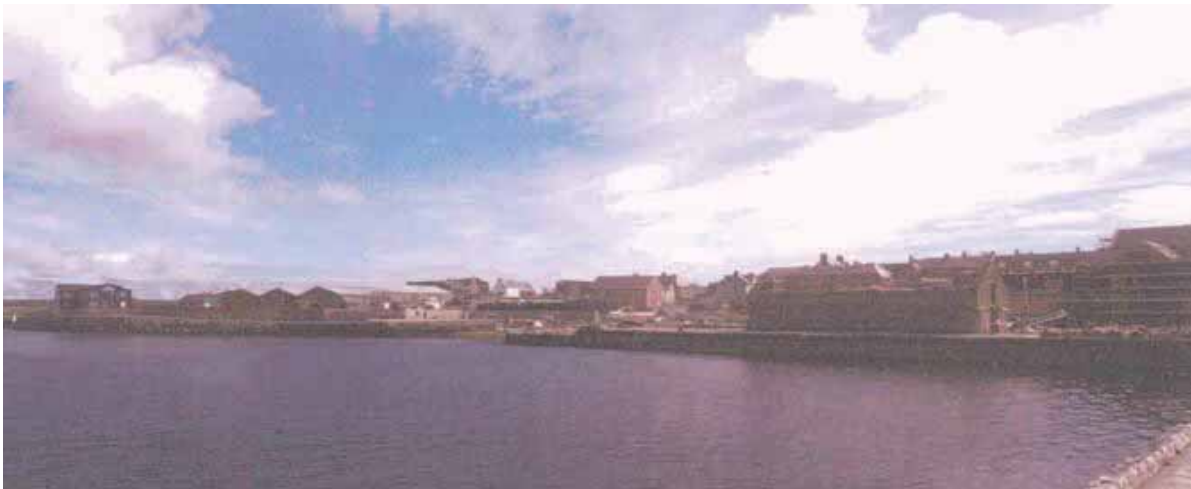
Panorama of Hay's Dock with the Heritage Centre under construction in the background (right), the restoration of the old sail house on the quay (centre right) and Cintec stabilisation work (end of the quay left of sail house).

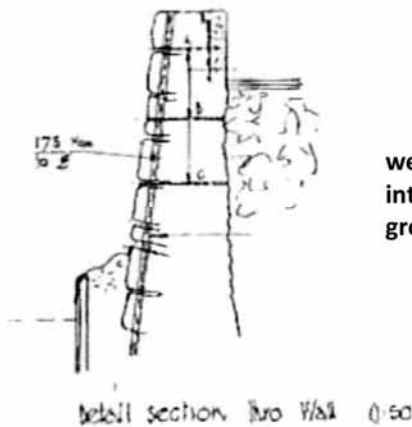
To overcome the problem, Torbay Borough Council proposed a design using Cintec anchors to pin the wall to the foundation. The anchors were inserted at an angle to mobilize the full length of the wall.

Additionally Cintec consolidation anchors were inserted on a regular grid to ensure the integrity of the wall and the action of the ground anchors on the wall.

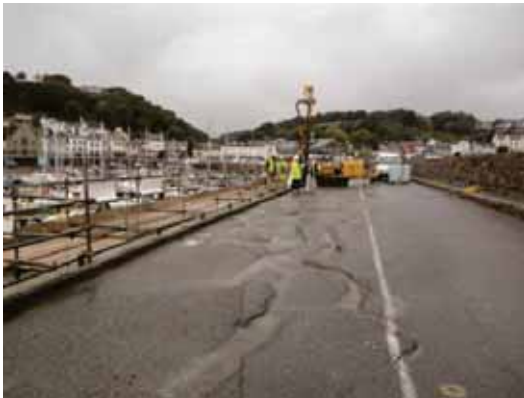
North Pier - cracks at deck level

In 2001 the North Pier was assessed as being in a state of instability due to movement of its internal wall and apparent settlement of the interior of the pier. The deck level of the North Pier is surfaced in asphalt which waterproofs the deck but also masks (to a certain extent) masonry movements. Large cracks however had developed and could be seen in the asphalt indicating a threat of impending

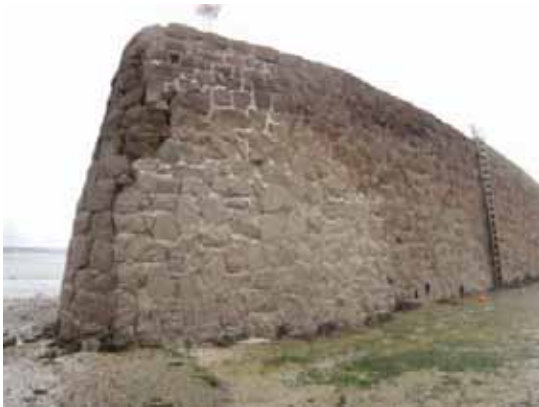
St Aubin’s Fort Breakwater has in turn suffered a re-occurrence of masonry movements and loss of pointing at its inner, lower deck wall.

In 2008 a bulge was also identified in part of this inner wall which prompted concerns about this part of the breakwater’s structural integrity.

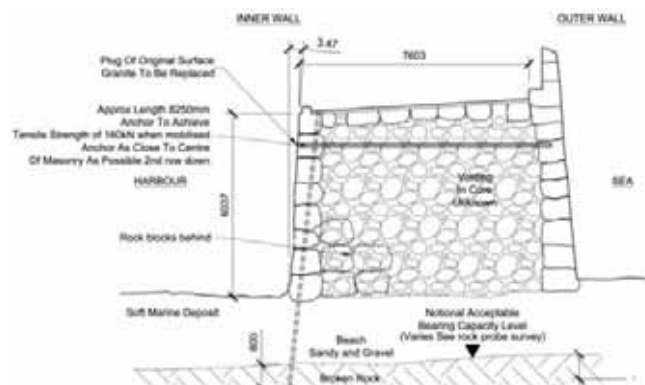
Figure 12 - Cross section of North Pier with stitching anchors

To resist the inner wall overturning, after pinning the base of the wall with vertical mini piles, requires a form of top restraint in the outward direction (Figure 12). The final design consisted of horizontal ‘passive’ ties from the inner wall to the outer face although inclined raking anchors through the core of the Pier tied into the Jersey rock shale were also considered.

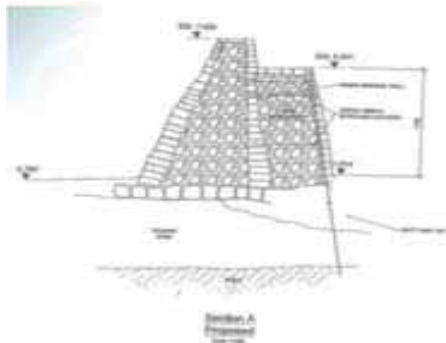
Figure 13 - St. Aubin's Fort inner wall ties and mini piles

by the sea conditions in such an exposed location. Horizontal ties were inserted through the inner wall of the main breakwater so that the inside face wall of the lower deck was not only tied to the inner bulk of the original wall but also had additional cantilevered ‘beam’ support.

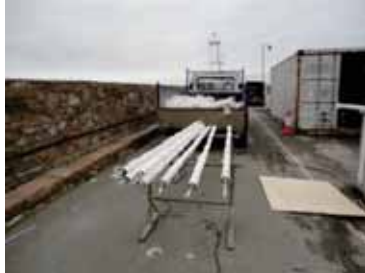
Figure 15 - Anchors with coupler

At the North Pier the vertical drilling works for the anchors took place through the inner wall concrete up-stand used for vessel mooring. Plugs in the masonry were reinserted to enable invisible fix (such as that shown in Figure 20) once the anchor had been installed. The supplier utilised standard 2.5m anchor lengths for both structures, coupled together to achieve vertical and horizontal lengths as required (Fig 15).

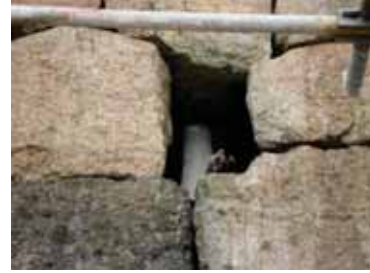
Figure 17 - Anchor expanded

furthermore mitigated pollution control concerns by the 'sock' principle of the anchor system where the grout is contained within a small radius of the sock diameter. Only a small surface area of grout oozes through the sock material to bond to the adjacent substrates and when cured, forms a concrete skin over the 'sock' material (Figure 16 before grouting injection/Figure 17 after grouting injection).

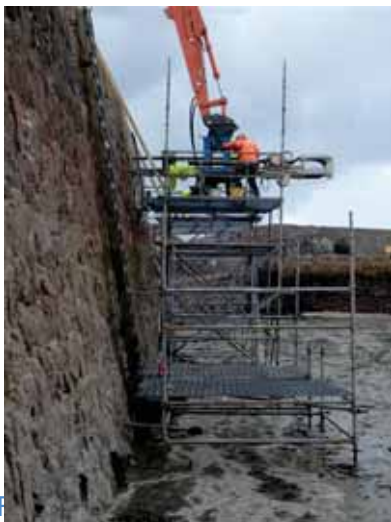
From a large machine platform aided by localised, demountable scaffolding the horizontal anchors were drilled and fixed (Figure 19). The number of verticals and horizontals at the inner wall of the Fort Breakwater required careful setting out to avoid conflicts and also to allow for flexibility with respect to deck positioning of the rig on the

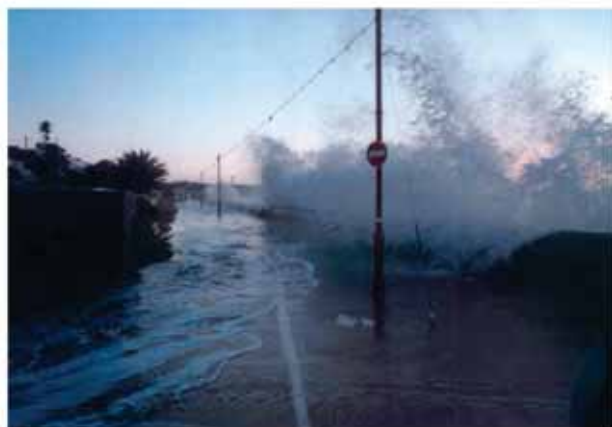
Figure 2. Inland flooding – overtopping and flooding at St Aubin's sea wall near the Gunsite slipway

The States of Jersey engineers commissioned the consultants, Arup Rothwell, to investigate the flooding problems (see Figure 2) and put forward engineering concepts for a solution to alleviate the flooding which included the option of raising the height of this World War II (WWII) concrete wall. Other options considered at this location, such as rock armour and groynes, were not thought viable because this part of the St Aubin's Bay beach is a popular tourist spot, and the solutions impinging on the beach amenity use, coupled with the cost of such methods, precluded their use at this location.

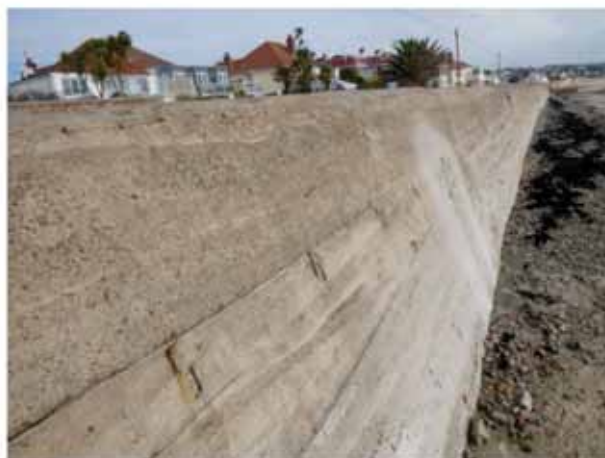
Figure 3. Shape of wall

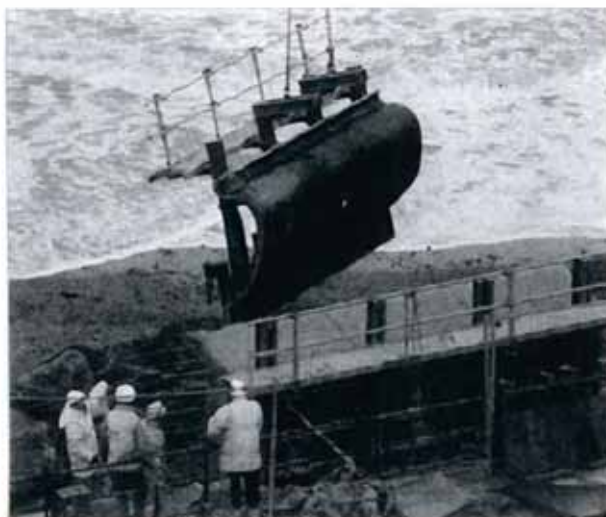
Figure 4. Typical shape of 'recurve' from Ciria C674 (Dupray *et al.*, 2010)

Arup undertook the flood study and assessed the volumes of water being produced by overtopping events and understanding where these volumes of water would be trapped and cause flooding. The objective of the study was to assess how high the existing WWII concrete sea wall had to be raised to prevent flooding or, at the very least, alleviate the flooding scenario inland, in particular at the roundabout. At the outset of the remediation design, the Construction Industry Research and Information Association (Ciria) guidance C674 on sea wall design (Dupray *et al.*, 2010) was used to provide an initial curved geometry and profile for a 'recurve' and capping beam that would be robust when subjected to the storm wave forces that impact on the existing WWII wall (see Figure 4).

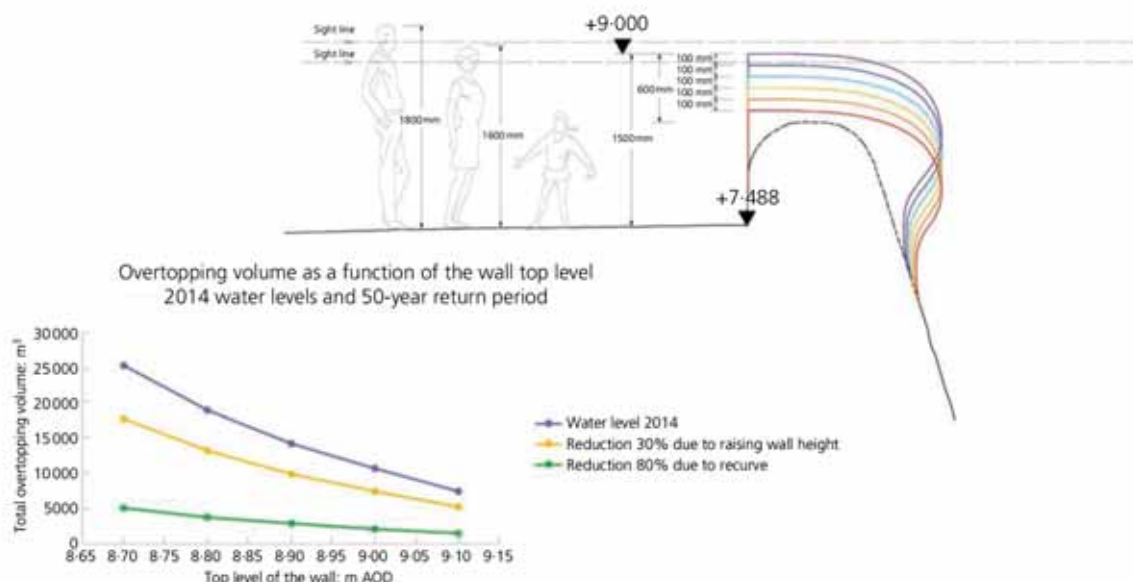
Figure 5. Overtopping options for various heights. m AOD, metres above ordance datum

The objective of the recurve is to ensure that the wave impacting on the wall is thrown backwards into the next oncoming wave, thus reducing the energy of the incoming wave and its wave energy at the wall together with its consequential overtopping volumes. The study looked at the relevant decrease in overtopping volumes that could be predicted, when the wall height was raised incrementally, accounting for sea level rise, storm increase and duration over a design life of a further 50 years. Various heights for raising the wall were analysed, and the relative reductions in overtopping volumes of these heights were predicted and plotted on the new cross-section (see Figure 5).

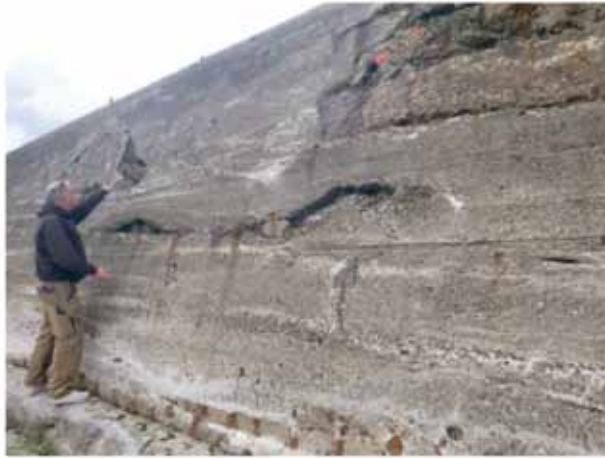
Figure 6. Poor surface of WWII wall with inclusions

The condition of the seaward surface of the original concrete wall was in a very variable condition (see Figure 6). In some areas, large surface loss has taken place, exposing aggregate and corroding reinforcement. The solution was to break out these areas of weakened concrete and repair with a fibre-reinforced spray concrete. Trial spray concrete areas were used to arrive at a satisfactory methodology for both the safe cutting out and replacement of material using spray concrete to achieve an appropriate concrete repair and an acceptable colour match.

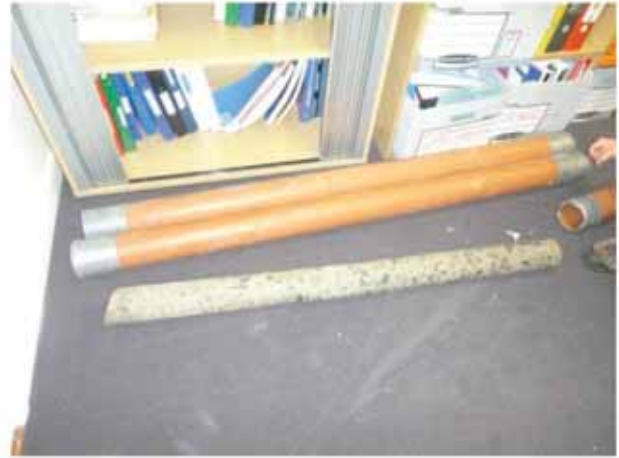
Figure 7. Concrete core intact through wall

The results of the horizontal cores indicated that the surface damage was to an approximate depth of only 20 or 30 mm, and, generally, the depth through the wall to 700 mm thickness was seen to be of consistent, reasonable quality concrete. The tensile strengths of concrete cores were in the 1.4–1.9 N/mm<sup>2</sup> region, and the crushing strengths were from 30 to 40 N/mm<sup>2</sup> (see Figure 7).

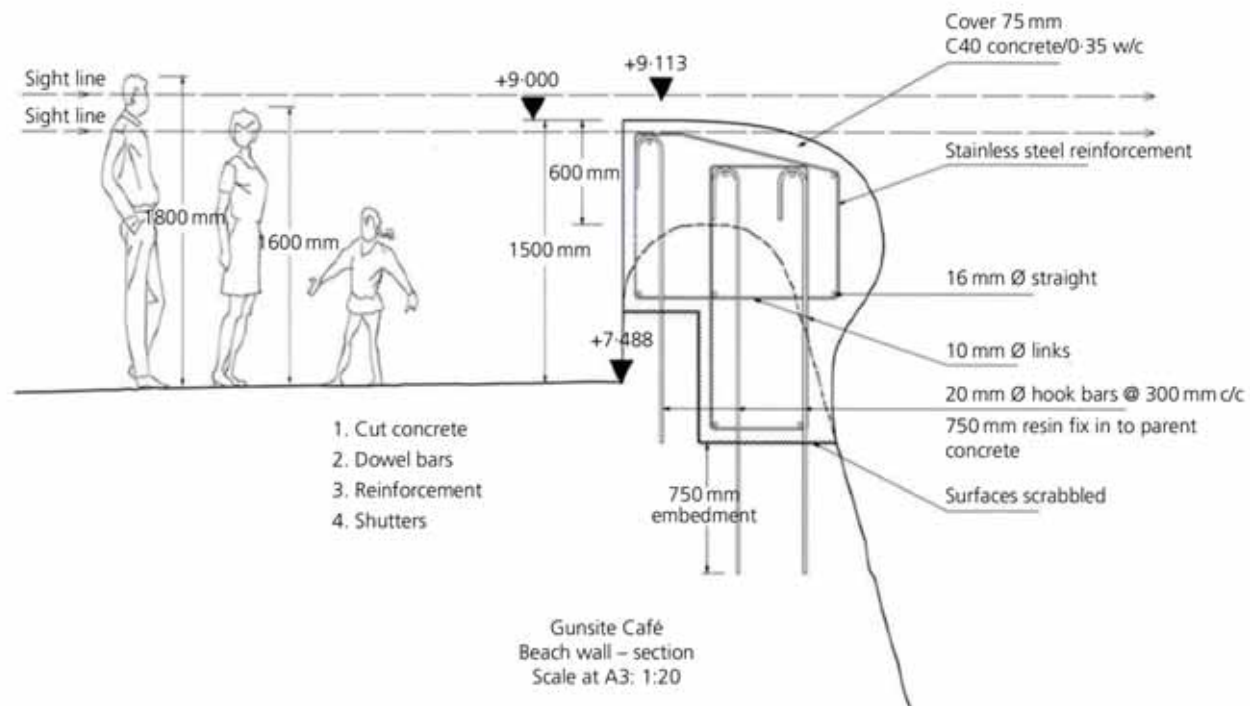
Figure 8. Initial design concept. c/c, centre-to-centre; w/c, water/cement ratio

Notionally the concrete to be placed on top of the existing sea wall needed to maximise the bond area created by the cutting off of the rounded and in many areas damaged top curved surface of the original wall. Two horizontal and one vertical surface cuts would provide a relatively large surface area for the new capping beam to be in contact with and cast on the original mass concrete below. The majority of the resistance to the wave uplift was required at the front of the wall where the overhang of the recurve presented a barrier to these upward forces. The need to spread the direct impact load of waves therefore required that the new capping beam would act as one unit although only a nominal amount of reinforcement would be needed so that the tying action between old and new concrete was uniform and spread over the new mass concrete length (see Figure 8).

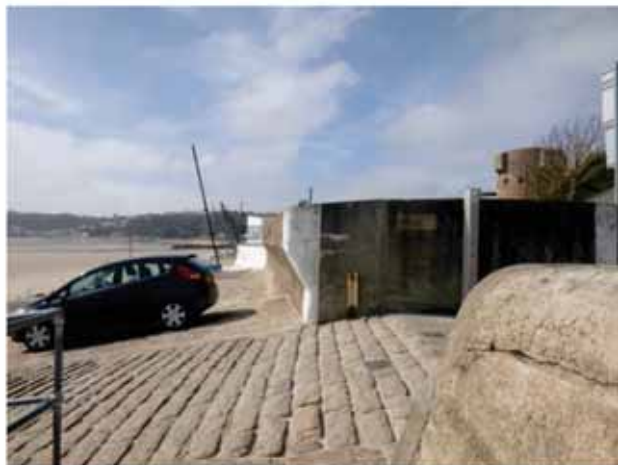
Figure 9. Gunsite angular recurve at the slipway

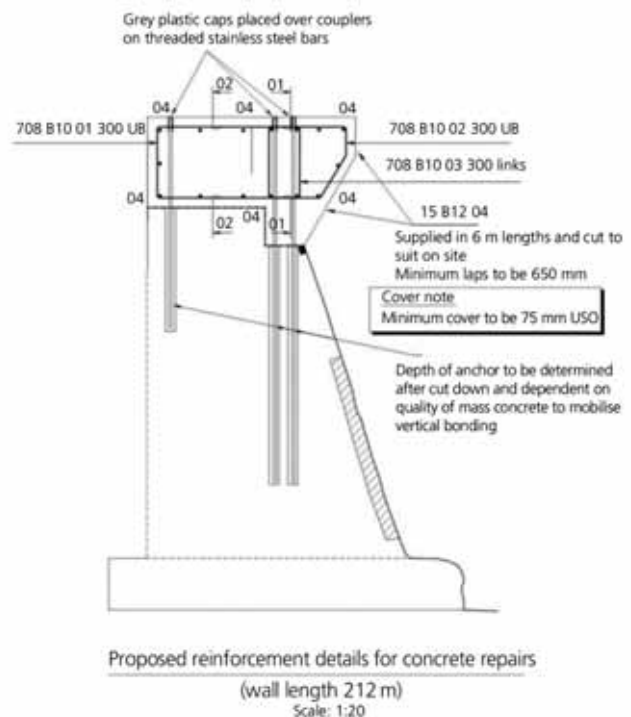
Figure 10. Angular modified recurve design

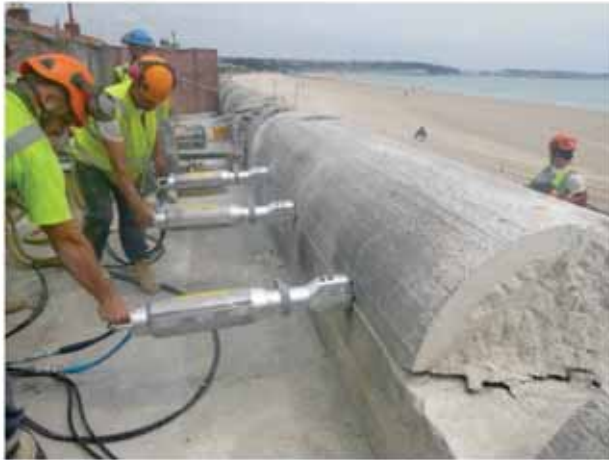
Figure 11. Concrete splitters removing the top of rounded wall

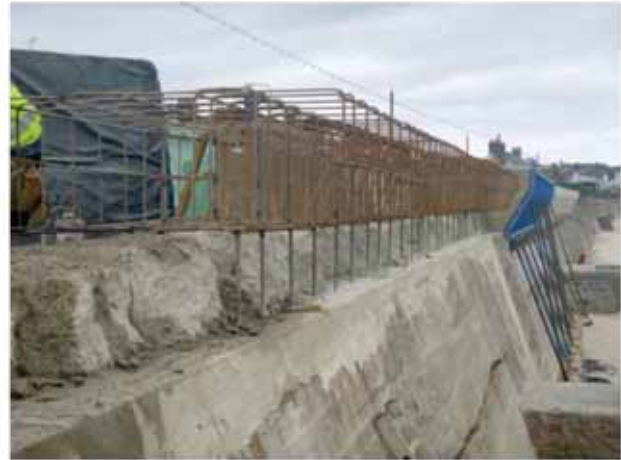
Figure 12. View of sequential construction of capping beam, raising the height and providing a recurve

In addition to utilising lidar for the surveying and modelling of this project, Cintec anchors provide the main tying and bonding connection between the old WWII concrete and new concrete. The new seaward-facing surface concrete was to be produced incorporating formwork using Zemdrain fabric on the shutter. Zemdrain produces a surface, which is hard wearing, has few surface defects, is more robust to wave impact and is more abrasion resistant. In addition to sand debris in the waves, a gravel bank is formed at the base of the sea wall and the gravel is then taken up in the waves and this has a very abrasive action. The Zemdrain-coated formwork was also used in 2006 for the St Ouens sea wall overlay and produced a very good antiabrasive result which has stood up well in an even more extreme environment than the one in St Aubin's Bay. The almost flat top of the capping beam has a shallow fall towards the sea and needed a 'non-smooth' surface so has been given a light 'rough brush' finish on top. The landward- or promenade-facing concrete has a normal F1 finish. Some minor volumetric and shrinkage cracking took place during the early work which was carried out in the hotter drier summer months. Leaving formwork in place for a longer period resulted in reducing this minor cracking during the progress of the works. The sequencing of the works is shown in Figure 12.

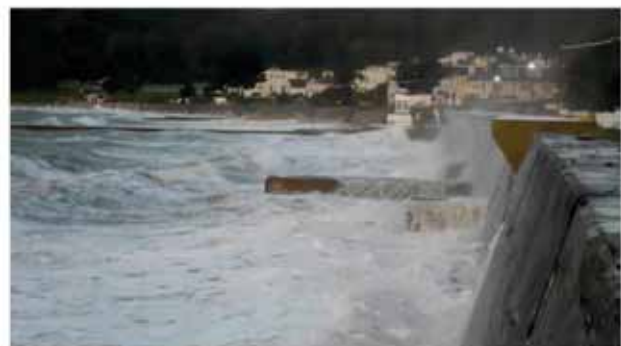
Figure 13. Performance of the wall reflecting waves

It is interesting to compare the wave action of the original WWII lower height wall with the performance of the raised new recurved profile wall because the new wave behaviour illustrates the reflected wave impact on incoming waves reducing the wave energy at the wall (Figure 13). The arrangement has yet to be tested against the maximum of storm surge, high tide and heavy rainfall, but it is anticipated that with the secondary defences at

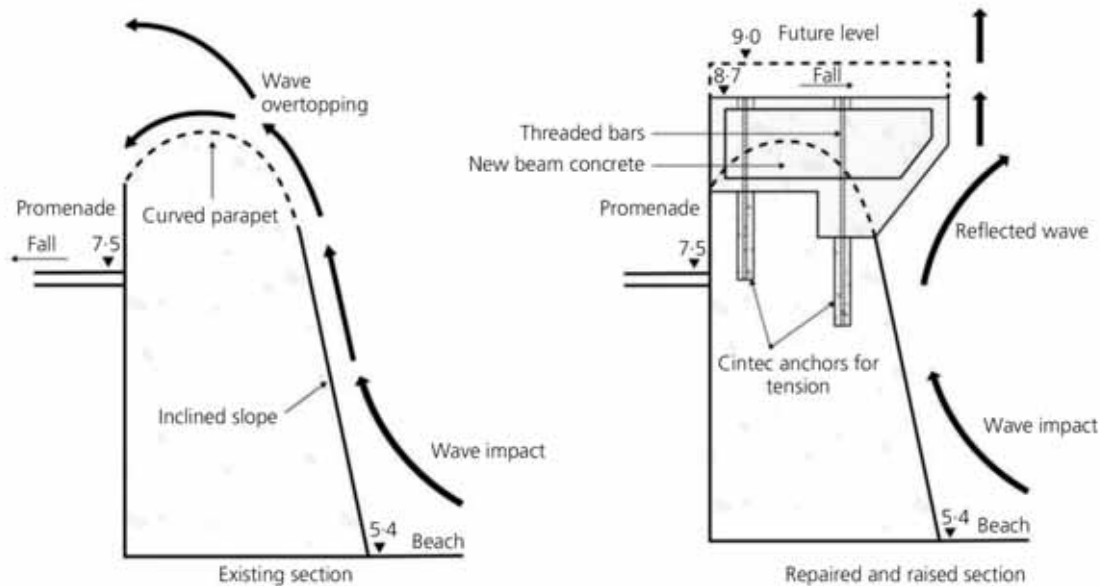
Figure 14. Scheme stage design concept before and after cross-section

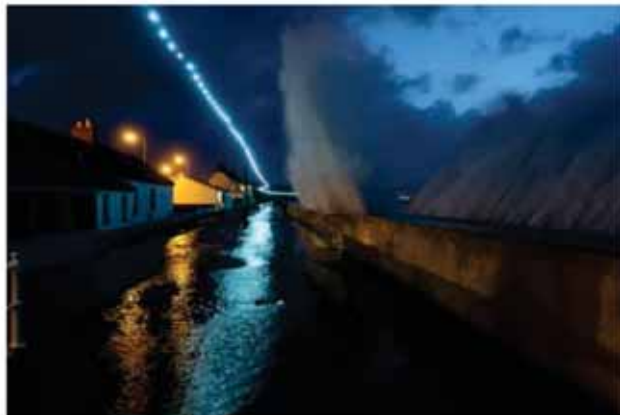
Figure 15. Storm wave action at new wave return wall and existing

However, high tide and wave conditions that occurred in January and February 2018 at the site provided an excellent practical demonstration of the theory of improvement to the wall being demonstrated on-site. Figure 14 shows the theory behind the scheme, but the very good photograph in Figure 15, taken by the site engineer from DfI, Ross Femley, captures nature behaving as the engineer intended. The split and change in direction of the wave is at the junction of the completed phase I work with the next section of the wall to be remodelled in phase II to match the phase I concept.

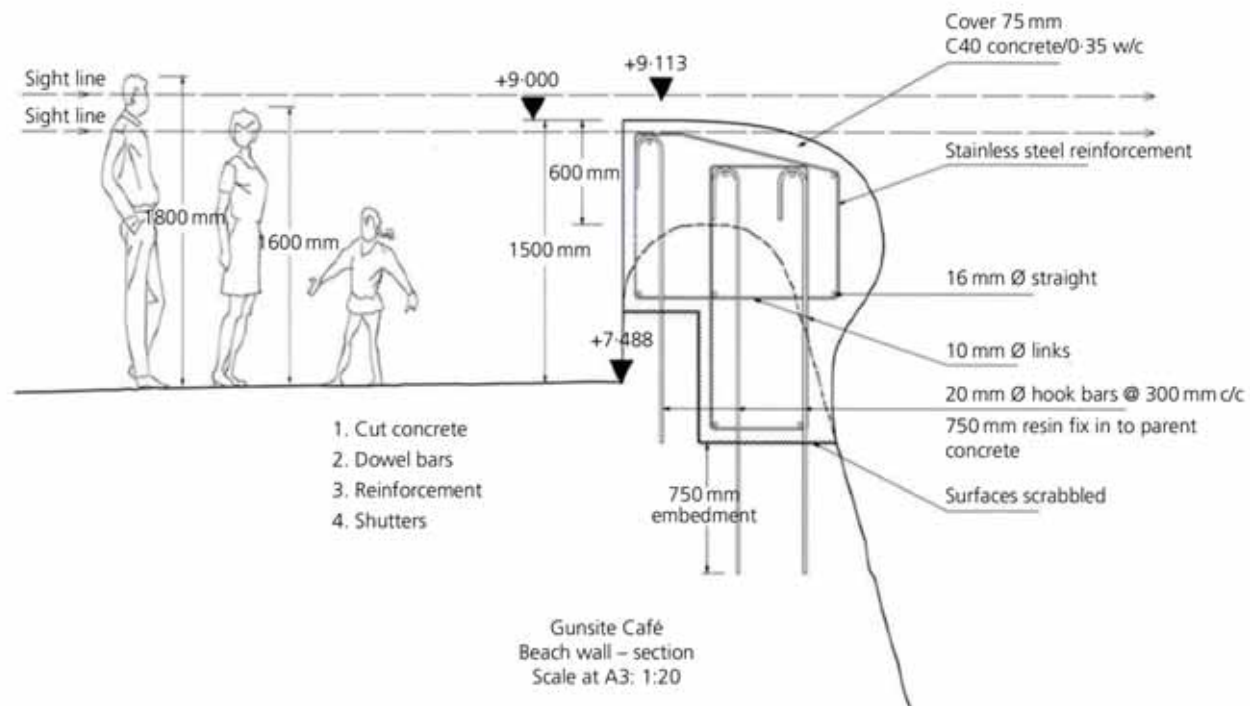
Figure 8. Initial design concept. c/c, centre-to-centre; w/c, water/cement ratio

Notionally the concrete to be placed on top of the existing sea wall needed to maximise the bond area created by the cutting off of the rounded and in many areas damaged top curved surface of the original wall. Two horizontal and one vertical surface cuts would provide a relatively large surface area for the new capping beam to be in contact with and cast on the original mass concrete below. The majority of the resistance to the wave uplift was required at the front of the wall where the overhang of the recurve presented a barrier to these upward forces. The need to spread the direct impact load of waves therefore required that the new capping beam would act as one unit although only a nominal amount of reinforcement would be needed so that the tying action between old and new concrete was uniform and spread over the new mass concrete length (see Figure 8).

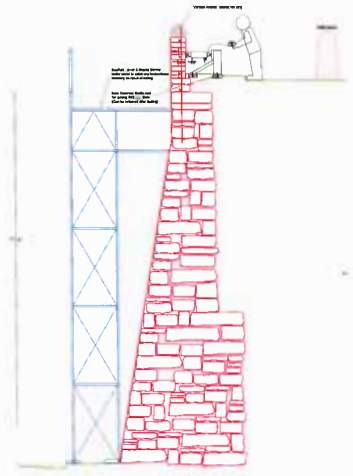
TYPICAL TESTING SET UP  
Scale 1:10

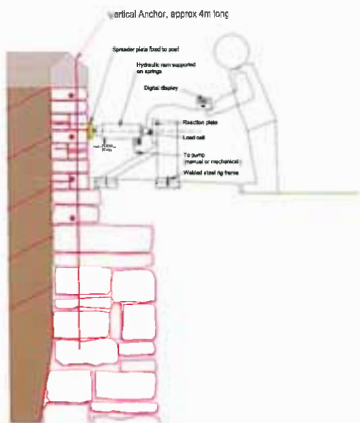
TESTING RIG  
Scale 1:2
