Case Study

**Anchoring the Past to
Secure Our Future:****Canada's
Parliamentary Hill**
Ottawa, ON

Seismic and structural reinforcement of the buildings

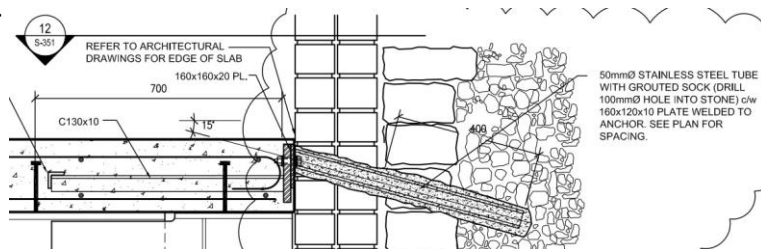
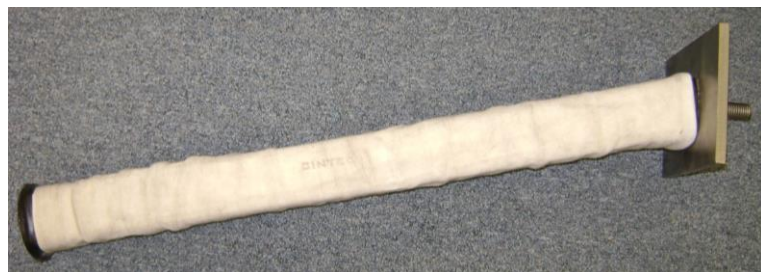
Cintec anchors were used throughout the project for wall consolidation and attaching stone façade to brick substrate. Much larger and robust anchors were used to strengthen walls and improve seismic response.

Above, Cintec Anchors used throughout the Project for wall consolidation and attaching stone façade to brick substrate. To the right, installation of the Cintec anchors used to **strengthen / seismic upgrading** of the West Block. Anchors were embedded into sound masonry and mechanical couplers were provided for connection of the stainless-steel rods.

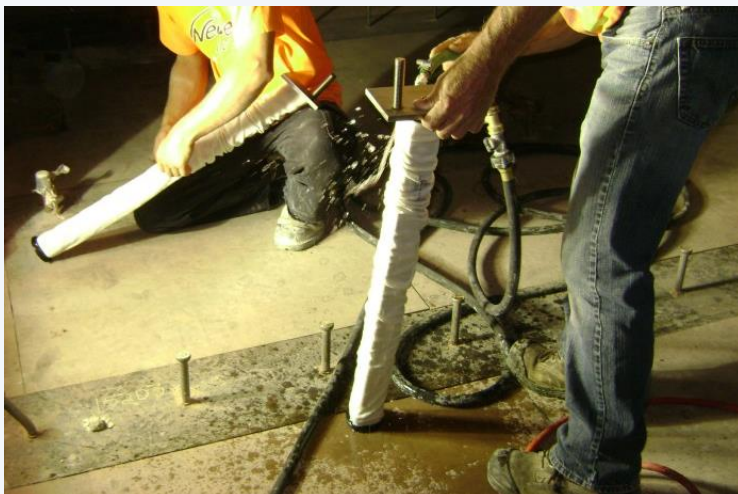
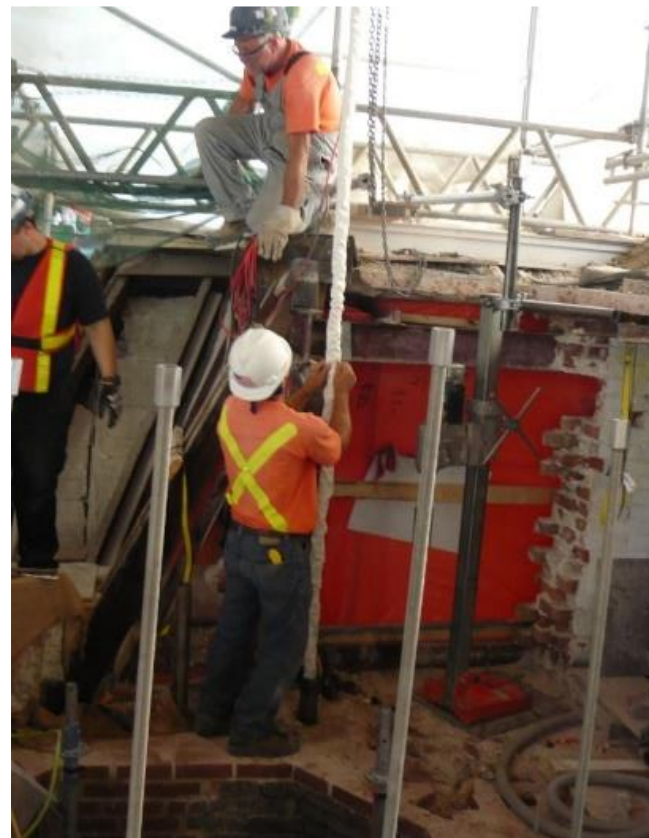
The Cintec anchors were custom-made to suit the requirements of each historical building and application
