Deansgate Viaduct, Manchester, U.K

"Key hole Surgery for Bridges"

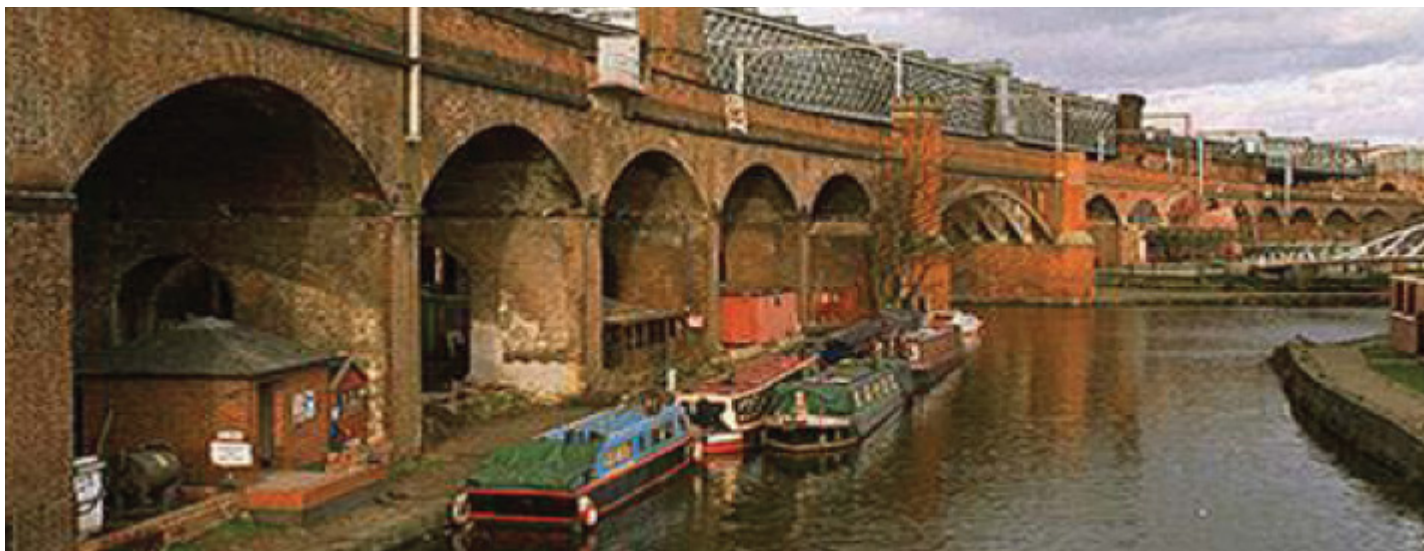
The busy Deansgate rail viaduct is situated in the heart of Manchester spanning numerous buildings, roads and canals. In 1997 the normal daily flow of rail-traffic was disrupted by a destructive fire which took hold in a workshop located directly underneath. The subsequent heat generated by the blaze caused extensive damage and a weakening of the seven rings of masonry that form the arch barrels. The surface ring of brickwork completely delaminated and collapsed to the ground below.

A team of consulting engineers assessed the damage and recommended a Cintec reinforcement solution. Any remnants of the outer ring were completely removed and the remaining six rings were hammer tested to locate the extent and area of

internal delamination. Two arches were found to be in need of repair. In total approximately 500, 24 inch long RAC Cintec anchors were installed, perpendicular to the arch and at spacings of 20 inches. The anchors were staggered to avoid the formation of sheer lines and because of their vertical aspect, each anchor was fitted with an air-vent tube to ensure full grout inflation without risk of air pockets being formed at their remote end. All anchors went no further than half way through the sixth ring so as not to puncture the original waterproof membrane that protects the arch barrel from the arch infill.

Finally the original appearance of the arches was restored by grouting an original piece from the drilled cores back into the mouth of each anchor hole. The completed work was rendered invisible to the naked eye and the viaduct was once again in operation servicing Deansgate station and the G-Mex
