‘Stitching up’ the past – The strengthening of three heritage marine structures in Jersey with needling technology

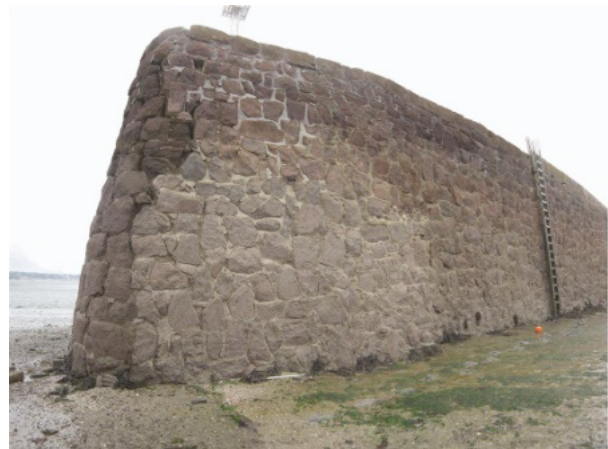
In 2001 the North Pier was assessed as being in a state of instability due to movement of its internal wall and apparent settlement of the interior of the pier. The deck level of the North Pier is surfaced in asphalt which waterproofs the deck but also masks (to a certain extent) masonry movements. Large cracks however had developed and could be seen in the asphalt indicating a threat of impending wedge failure of a section of the inner wall.

North Pier - cracks at deck level
