Worcester Viaduct

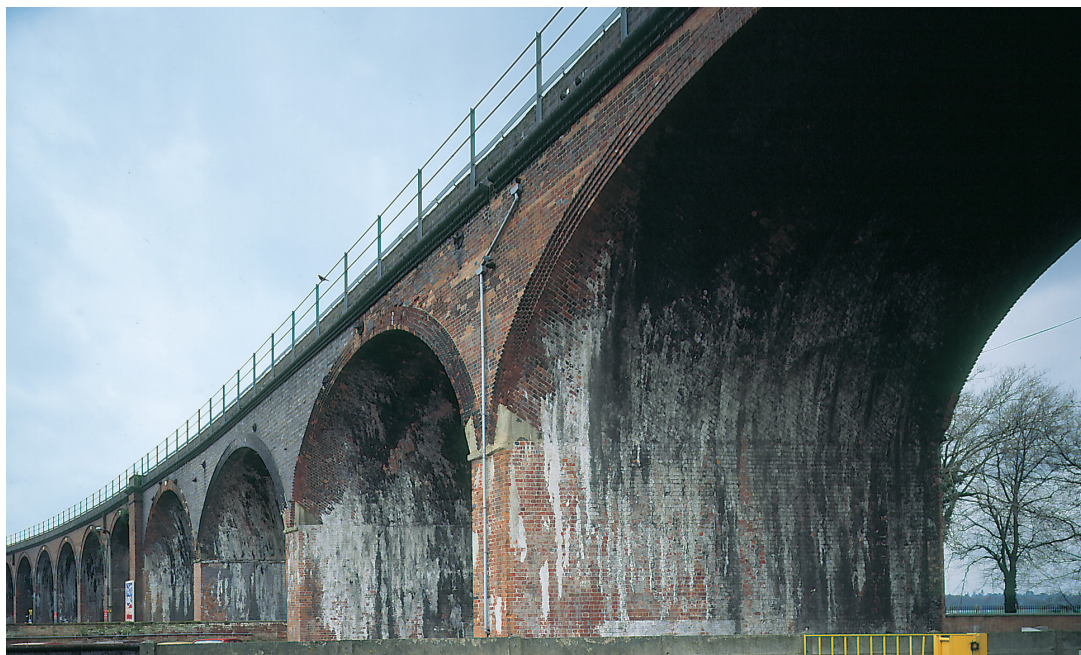
Worcester Viaduct comprises sixty-five brickwork arches rising from approximately two storey height near the railway station to over three storey height as it approaches the river. Lack of proper draining within the arch had led to the spandrel walls being forced away from the intrados arch with longitudinal cracks close to the longitudinal edges of the bridge. Water penetration had contributed to cracking at the springings of some spans and delamination of external parts of some columns. These problems had been exacerbated by weathering, particularly freezing and thawing. Previous efforts to restore the structural integrity were evident, but had proved ineffective.

Transverse 30 x 30 x 3 SHS stainless steel WSA anchors were installed to restore the integrity of the spandrel wall/ intrados arch connection at approximately 750mm centre-to-centre and alternate lengths of 2.0m and 2.5m. Stitching anchors were angled across the longitudinal cracks to restore structural integrity and the cracks were then filled. Transverse and diagonal stitching anchors, type RWT, 15 x 15 x 1.5 SHS stainless steel, were installed to restore the strength of the delaminated columns and the cracks filled. Drainage holes were drilled through the intrados and plastic pipes were installed to help relieve the existing water pressure. To date five spans have been renovated using the Cintec system and further spans will be renovated as part of an ongoing maintenance programme.
