Fall River, Massachusetts Rt 79 Exchange

This stone arch bridge over Quequechan River on Central Street in Fall River, Massachusetts was built in 1903 and has a span: 25.9 ft. length: 34.1 ft. and deck width: 26.2 ft. The bridge currently has an operating rating 102.3 tons (93.0 metric tons) an inventory rating 102.3 tons (93.0 metric tons). The evaluation is structurally deficient with a rating of 52.2. This rating warranted a remedial repair in conjunction with the rebuilding of the RT 79 interchange.

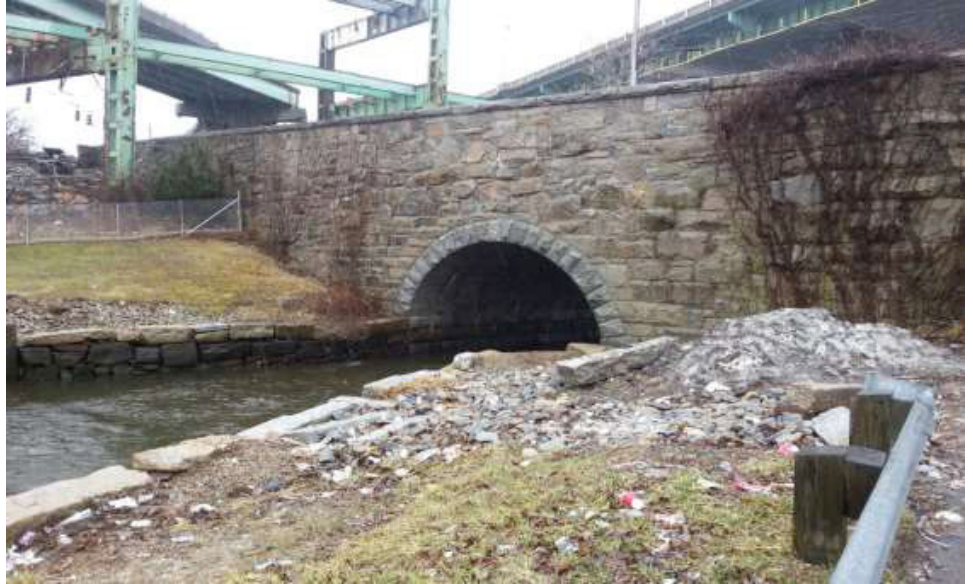
North Side Elevation

Within the barrel of the bridge seven cracks have developed over the years with crack separation from .25 inches to 3 inches in various locations. (See: Vertical Crack) The owner decided not to replace the tidal waterway but to consolidate the ring granite stones in place. Ramboll Engineers in calibration with Cintec America designed a remedial repair scheme which would allow the bridge to retain its original look and stay in service while the repairs were being done to the bridge. During the drilling and anchors inflation the bridge stayed in use with an average traffic flow of 6,000 cars a day.

The remedial repair consisted of wet core drilling 8, 2" diameter holes into the face arch ring stones from the North and South direction. The drilled 18 drilled hole lengths were 18.4", 27.4" or 16.4". The length were designed so they intersected the cracks and extended 8' last the last crack. After the holes were drilled Cintec anchors which, are number 8 stainless steel rebar grade 2205 (1") encased in a patented sock were inserted to the holes and Cintec grout pumped into the sock. The cementitious grout inflates the sock and locks the stainless steel rebar in place through the full length of the drilled hole through the arch stones. The drilling and installation of the Cintec anchors was performed by Cintec directly.
